# IMPACT OF DEVASTATING EARTHQUAKES IN CROATIA IN 2020

Mario Uroš\*, Josip Atalić, Marija Demšić, Maja Baniček, Marta Šavor Novak, Alen Kadić

Department of Engineering Mechanics, Croatian Centre for Earthquake Engineering,  
University of Zagreb Faculty of Civil Engineering, Zagreb, Croatia

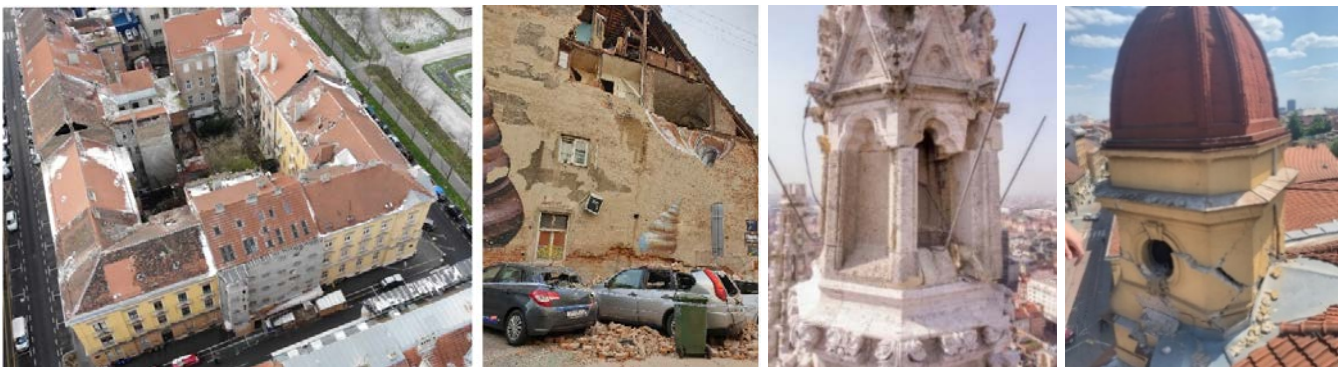
Fig. 2. Zagreb earthquake (source: HCPI, 2020; AIR-RMLD d.o.o.)

Traditional masonry buildings in Zagreb were mostly built as systems of load-bearing walls and wooden floor structures with inadequate connections. Generally, the floor structures are supported by the longitudinal walls running parallel to the street [9]. The buildings in the historic city centre are mainly built in relatively regular and large blocks with a complex interaction (Figure 2). Due to lack of maintenance, the material deteriorates quite quickly, increasing the inhomogeneity of the walls and the loss of binding material. Cantilevered high walls and their out-of-plane mechanism are the biggest problem (Figure 2).

Typically observed damage includes collapses and damage to chimneys, gable walls and various other cantilevered elements (attics, cupolas, etc.), detachment of gable walls at height, roof damage, in-plane damage of masonry walls with characteristic diagonal cracks - often along mortar bed joints, damage to lintels and vaults, stairs and partitions [9,10]. In addition, decorative elements were significantly damaged, which, despite their cultural value, pose a great danger in the event of another earthquake (Figure 2). The classification and degree of damage as well as the usability of the buildings after the earthquake are described in detail in [11].

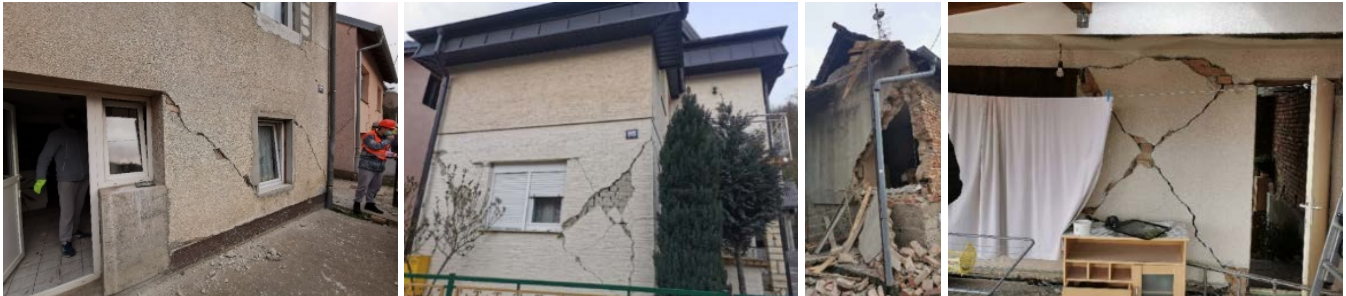
Fig. 3. Zagreb earthquake [14]

The damaged residential buildings in the epicentral area were built mainly after WW2. They are mainly unreinforced masonry structures or mixed systems without any standard (Figure 3). The lightweight roofing material is generally attached to the upper edge of the walls or tied loosely. The floor slabs consist mainly of prefabricated elements or reinforced concrete slabs. Mostly of them in epicentral area have significant in-plane damage and diagonal cracks. The typical damage is shown in Figure 3.

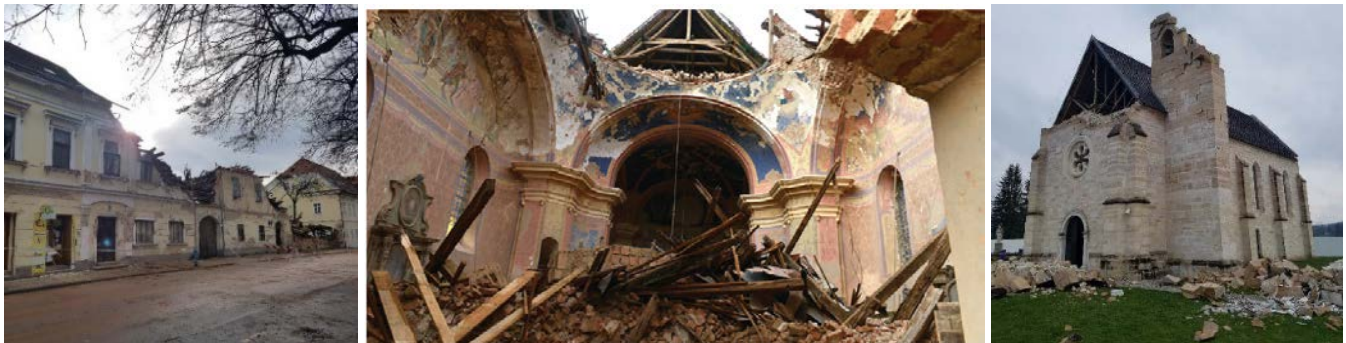
More than 50,000 building inspections have been conducted by engineers. The older unreinforced masonry buildings were most damaged. Many of these old buildings are in the historic centers of Petrinja, Glina, and Sisak, which are protected cultural heritage sites (Figure 4.)

Fig. 4. Petrinja earthquake, (a) center of Petrinja [14], (b) Church of St. Nikola and Vid, Žažina (source: Ministry of Culture and Media) (c) Church Mother of God, Gora [14]

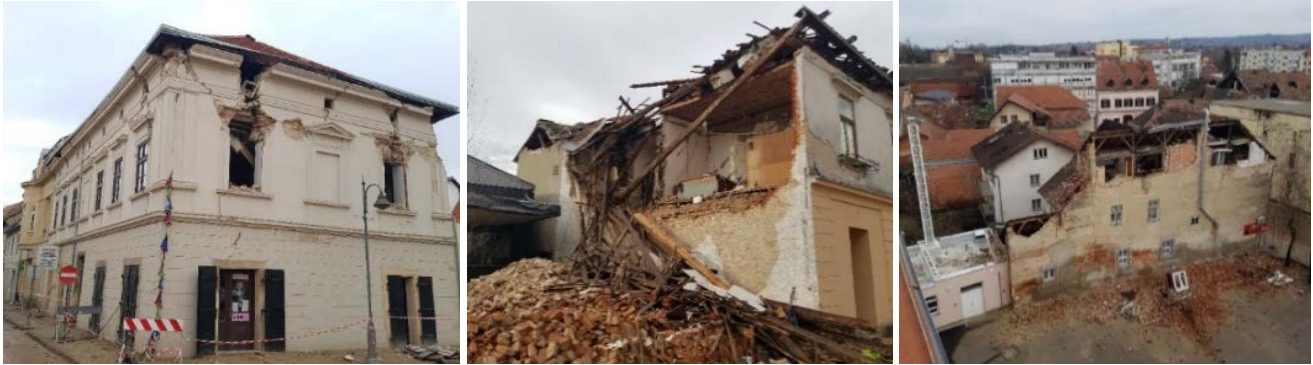
Majority of the brick and lime mortar masonry structures with wooden floor structures in historical urban centres dates to the late 18th and early 19th centuries. The roof structure consists of timber beams, often lacking adequate stabilizing components. The usual damage was the out-of-plane failure of the walls. The ground floor's load-bearing walls sustained minimal damage, unlike the upper floors. There was extensive damage to spandrels and arches, and slight to moderate in-plane damage of primary walls (Figure 5). Consequently, the failures of gable walls and facade walls on the upper floors led to destabilization and, in many cases, the collapse of the roof structures.

Fig. 5. Petrinja – typical damages [14]

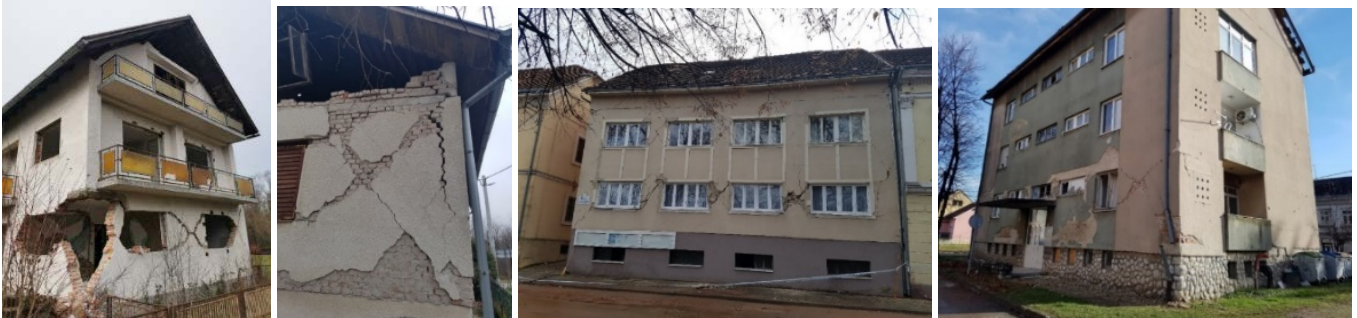
Fig. 6. Petrinja [14]

In many buildings with relatively stiff floor structures, in-plane failure mechanism was observed (Figure 6). The shear mechanism in these walls typically showed diagonal cracks and joint cracking due to the substandard mortar quality.
