THE ASSESSMENT AND REPAIR OF THE PRECAST RC STRUCTURE EXPOSED TO FIRE

This paper presents the assessment and repair of precast RC structure exposed to fire in Novi Sad. Detailed visual inspection, which includes described and classified damages and defects of RC columns and beams, is presented in the paper. Control design of the built-in concrete and reinforcement, as well as geodetic survey and conclusion on the state of the structure, are carried out. Two possible repair solutions were analysed.

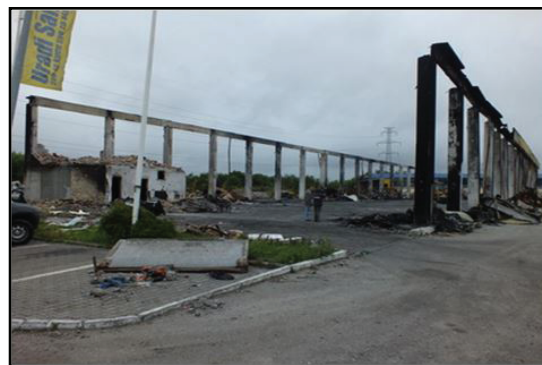
On May 5th 2013. there was a fire in production hall-building "Uradi sam" in Novi Sad. Major interior parts with installations, roof coverings and facade's cladding, as well as complete roof-bearing structure have been destroyed during the fire. RC columns and RC facade beams have suffered serious damages. Object's appearance before and after fire and clearing the ground off, are presented in Figures 1 and 2.

Figure 2: Object's appearance after fire and clearing the ground off

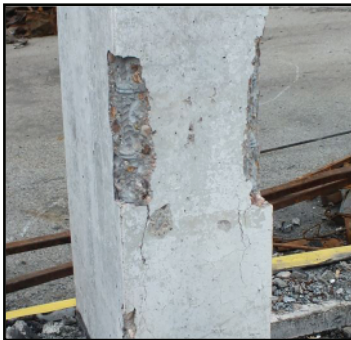
Figure 3: Cracking, separation and peeling of concrete along the column edges (up to the main longitudinal reinforcement), pronounced change in aggregate colour, net-like fissures

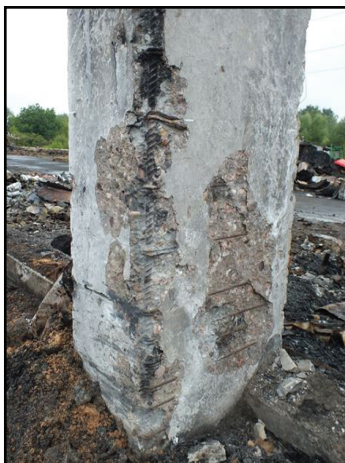
Figure 4: Peeling of crumbly protective layer of concrete, visible reinforcement

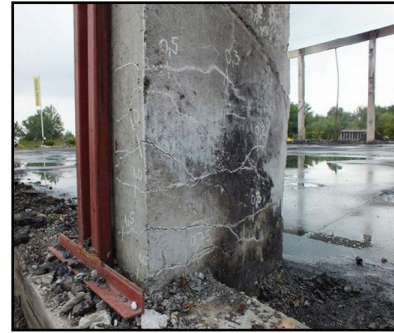
Figure 5: Horizontal cracks due to flexion of column (during the collapse of roof structure)

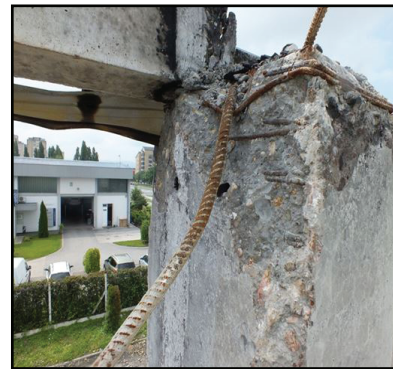
Figure 6: Crumbling of concrete in the supporting zone, peeling of surface and protective concrete layers, deformed stirrups and anchors, change in aggregate colour

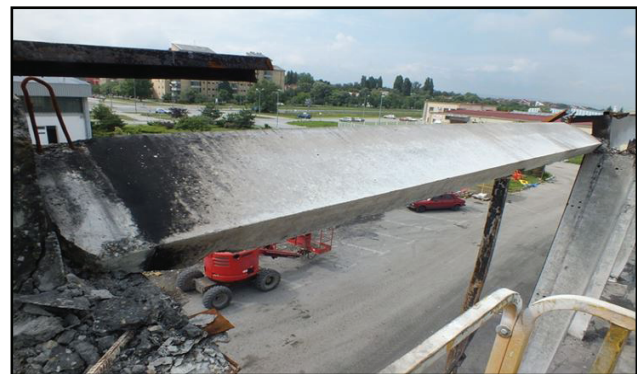
Figure 7: Beam rotation (tends to decline)

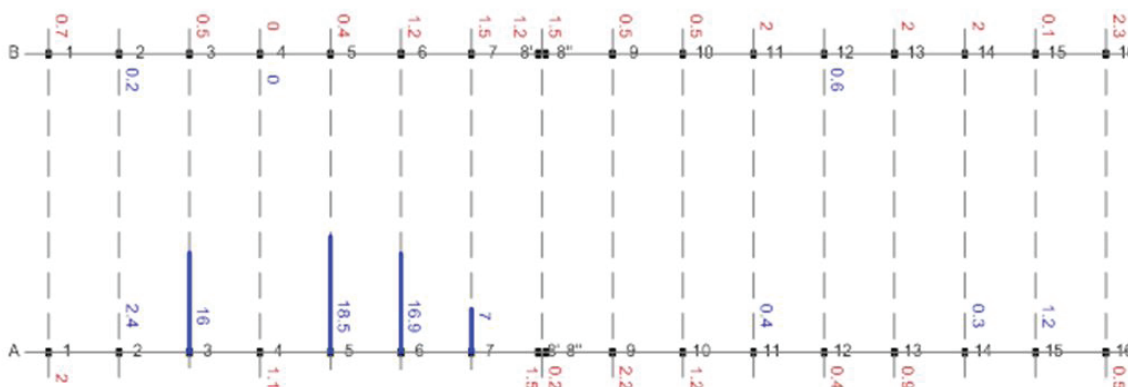
Figure 8: Schematic display of movement of the top of the column in relation to vertical axis

Columns A3, A5, A6 and A7 are evidently inclined towards the interior of the hall. Deviations of top parts of these columns in relation to fixed part of the column, i.e. in relation to the axis of non-deformed column, are great and are between 71-185 mm. Most of the columns were not deformed, nor was there excess of tension due to bending, because the main roof carrier fell from their supports relatively fast. However, on columns A3, A5, A6 and A7 connection between anchors on the top of the column and main roof carriers broke only after columns started to bend.
