ANALYSIS OF NATURALLY ETCHED SURFACE OF BRASS SHEATHING FROM A NINETEENTH-CENTURY SHIPWRECK

The Akko Tower Wreck is entirely the remains of a 25-m-long merchant brig, dated to the first half of the nineteenth century. During the 2015 underwater excavation, a piece of brass sheet was retrieved from the shipwreck and its surface and bulk were examined by metallurgical analyses. The examinations revealed a unique example of almost two hundred years' natural etching, which took place in the sea underwater environment. The surface of the sheet was covered with different copper and zinc oxides, which were identified by XRD analysis. Observation of the naturally etched surface with multi-focal light microscopy and SEM-EDS analysis indicated a microstructure of annealed α -brass, similar to that of its bulk. S-OES chemical analysis of the bulk revealed a composition of 65.0 wt% Cu, 34.4 wt% Zn and 0.6 wt% Pb. Based on the thickness of the sheet and its good state of preservation, it is suggested that it was used as sheathing to protect the hull against marine organisms, and to improve the sailing qualities of the ship. The results provide further information about the Akko Tower shipwreck

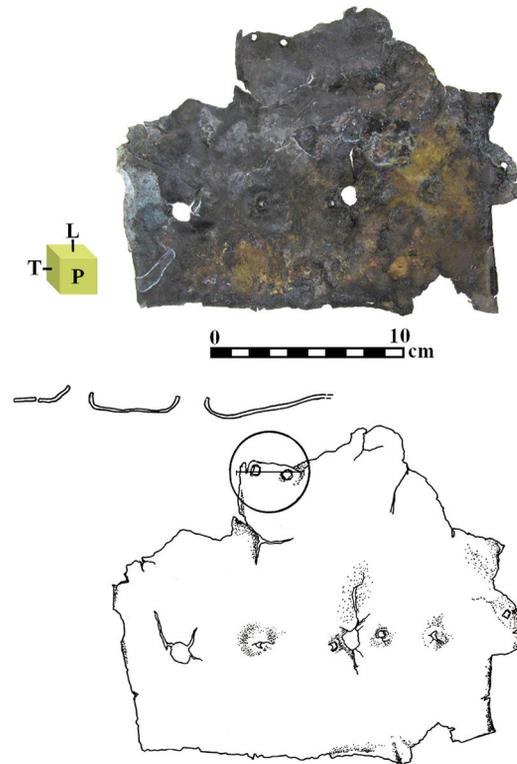
Along the longitudinal axis of the sheet are two types of holes, apparently for elliptical and square nails (Figs. 2 and 3). The sheet is slightly folded around the rim of each hole, indicating the direction in which the nails were driven. There are two elliptical holes 7.8 cm apart; one is 9.7×10.7 mm in size, and the other is 9.0×10.2 mm. The square nail holes are spaced at 1–3 cm in two rows: five on the same axis as the elliptical holes, and two close to the surviving edge of the sheet. The square nail sides range between 1.7 mm and 3.7 mm with an average side of 2.9 mm.

Figure 2. The as-retrieved brass sheet fragment covered with oxide coating (Photo: D. Cvikel; Drawing: R. Pollak)

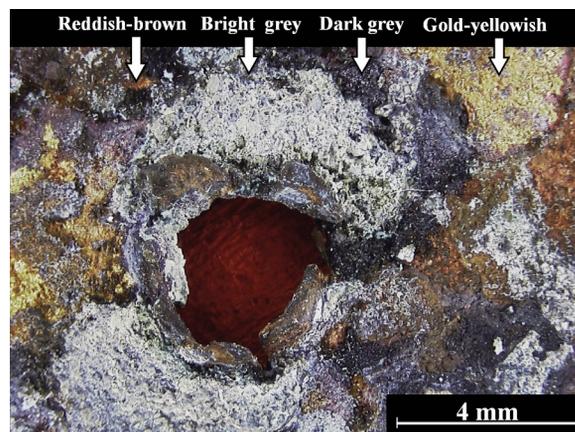
Figure 3. Multi-focal LM image of the sheet, showing a square hole with deformed boundaries, surrounded by different oxide colours

The corrosion products on the surface of the sheet had a composition of about ~50 wt% Cu and ~30 wt% Zn with C, O, S and Cl contaminants according to EDS analysis (before grinding). The colour differences on the surface of the sheet (Fig. 3) may be a result of the surface composition: blue is possibly copper hydroxide and chlorides (posnjakite); green is usually related to copper sulphates (atacamite, paratacamite, brochantite) and/or with basic copper chlorides; turquoise colour may be related to the presence of namuwite and/or to hydrous copper chlorosulphate (connellite); white is most likely related to zinc compounds, e.g. zinc oxide/hydroxide and zinc chloride; the gold-yellowish colour is attributed to CuCl_2 (tolbacite); pink may be attributed to zinc hydroxichloride; and the reddish colour is due to cuprite [11, 35–39]. The XRD results of the sheet's surface revealed presence of metallic brass as well as different oxides, including cuprite, namuwite, connellite and hydrated zinc chlorosulphate (Fig. 5).

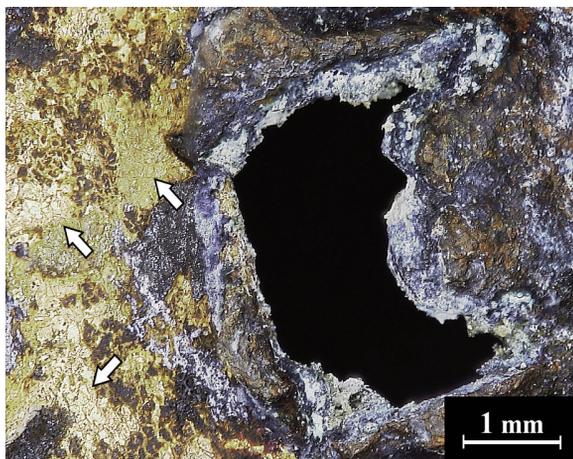
VT and multi-focal LM NDT observation of the sheet surface revealed holes with deformed boundaries (Figs. 2, 3 and 4). The sheet was covered with heterogeneous layers of oxide, mostly brown to dark green, with some areas yellow-golden, blue, white and pink (Figs. 3 and 4). The LM observation also revealed naturally etched metal with equiaxed α grains (Fig. 4). The oxide layers thickness (T-CS) was measured by LM (after mechanical grinding, polishing and etching), and was 10–150 μm .

Figure 4. Multi-focal LM image of the sheet showing a hole with deformed boundaries, surrounded by different oxides and areas of naturally etched metal with equiaxed α grains (left side of the image, arrows)

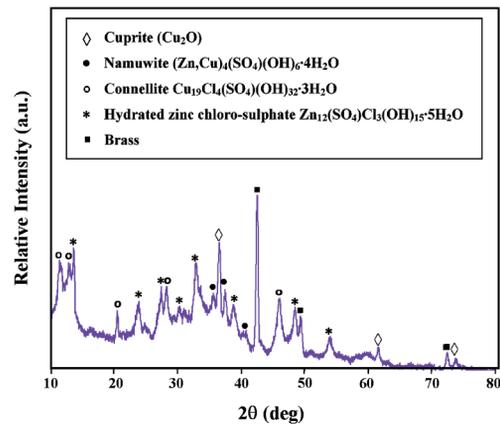
The XRD destructive analysis of the sheet surface revealed presence of metallic brass, as well as the presence of different oxides, including cuprite, Cu_2O ; namuwite, $(\text{Zn,Cu})_4(\text{SO}_4)(\text{OH})_6 \cdot 4\text{H}_2\text{O}$; connellite, $\text{Cu}_{19}\text{Cl}_4(\text{SO}_4)(\text{OH})_{32} \cdot 3\text{H}_2\text{O}$; and hydrated zinc chloro-sulphate, $\text{Zn}_{12}(\text{SO}_4)\text{Cl}_3(\text{OH})_{15} \cdot 5\text{H}_2\text{O}$ (Fig. 5).

Figure 5. XRD results of the as-retrieved sheet's oxide surface

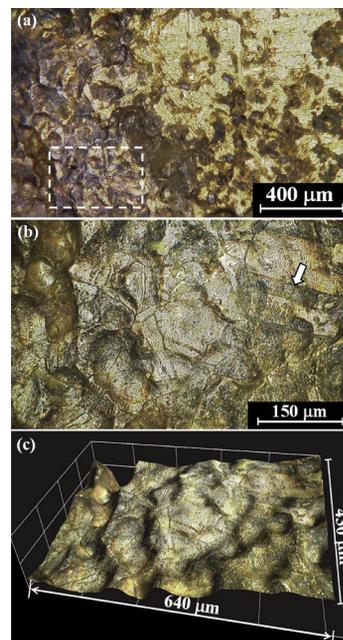
Figure 6. LM images of the as-retrieved sheet (P-section), showing: (a) general view; (b) equiaxed α grains and some annealing twins (white arrow); and (c) 3D image of the roughness of the naturally etched sheet's surface

LM image observation of the sheet revealed that it was naturally etched during the long burial period in sea water, with presence of equiaxed α grains and annealing twins (Fig. 6). 3D imaging of the naturally etched sheet exposed the rough surface of the α -brass grains (Fig. 6c).

The exposed as-retrieved brass microstructure, of equiaxed α -grain and annealing twins, observed on the sheet's surface (Figs. 6 and 7) is most likely the

result of intensive local etching of its surface in seawater due to specific defects (e.g. micro-cracks, stress), caused during the manufacture of the sheet. An example of such defects related to the manufacturing process of the sheet is the presence of grain boundaries and areas rich in deformation slip bands (Fig. 9). This makes brass surface electrochemically non-uniform in a corrosive environment. Corrosion cells at α -brass surface are not very effective in a neutral medium, but in acidic solutions, their current increases significantly. That is why α -brasses are etched non-uniformly in acidic media due to intensive dissolution of the intergranular space enriched in zinc [57]. Since the corrosion rate is dependent on various factors, such as temperature, pH, salinity and dissolved oxygen concentration of sea water, bio-activity, wave action, monsoon rain and settlement which are seasonally variable, the fluctuation of the surrounding environments, as well as storms or mechanical damage of the protective oxide coating, allow partial dissolution of the brass corrosion product or its peeling off the substrate, exposing the brass to renewed corrosion, resulting in native etching of the brass surface (Figs. 6 and 7).

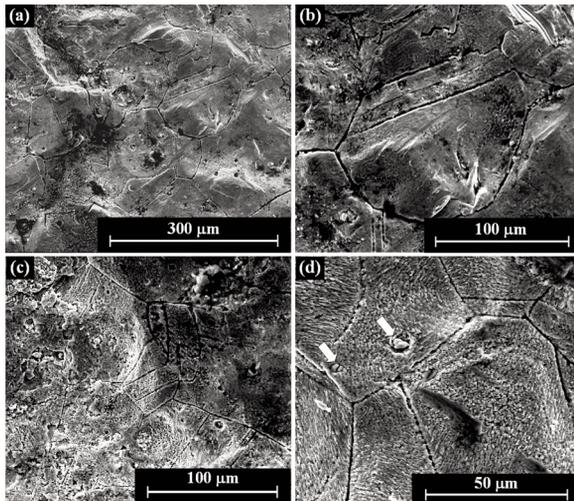
SEM observation of the as-retrieved sheet (with no further laboratory treatment) revealed α -brass grains with annealing twins (Fig. 7). A similar microstructure

Figure 7. SEM images of the natural etched sheet (SE mode, P-section): (a) general view of equiaxed grains; (b) grain with annealing twins ($\times 494$ magnification); (c) rough surface with α grains and annealing twins; and (d) rough surface with embedded inclusions (arrows)

The EDS analysis of the as-retrieved surface (area of exposed metal grains, Figs. 7a–7b) showed a composition of 49.7–49.9 wt% Cu, 28.3–30.6 wt% Zn, 6.9–9.7 wt% C, 7.9–12.8 wt% O, 0.9 wt% S and 1.2 wt% Cl (average values shown in Table 3). The EDS analysis results of the sheet after polishing its surface (Fig. 9) revealed a composition of 52.1–65.3 wt% Cu, 14.2–24.5 wt% Zn, 11.0–28.0 wt% O, 0.9–4.5 wt% S and 0.7–1.5 wt% Cl (average values shown in Table 3).

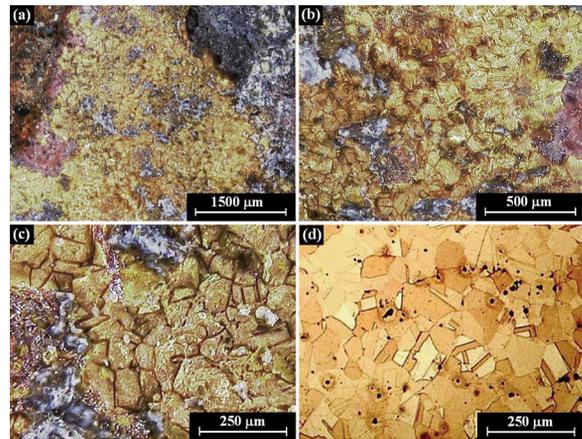
of equiaxed grains with annealing twins, as well as deformation slip bands, was also observed by LM and SEM at the P-section after chemically polishing the sheet's surface with phosphoric acid + nitric-acid + acetic acid ($\text{H}_3\text{PO}_4 \cdot \text{HNO}_3 \cdot \text{CH}_3\text{COOH}$) solution (Figs. 8a–8c and Fig. 9, respectively).

Figure 8. LM images of the sheet (P-section): (a) general view of the surface (polished, multi-focal LM) with brown, red, and pink colours of oxides (left side of image), and grey and black colours of oxides (right side of image) and exposed metal (centre of image); (b) different oxides and metal grains (polished, multi-focal LM); (c) equiaxed α grains and annealing twins (polished, multi-focal LM); and (d) metallographic image of the equiaxed α grains, annealing twins and inclusions (ground, polished and etched sample, LM).

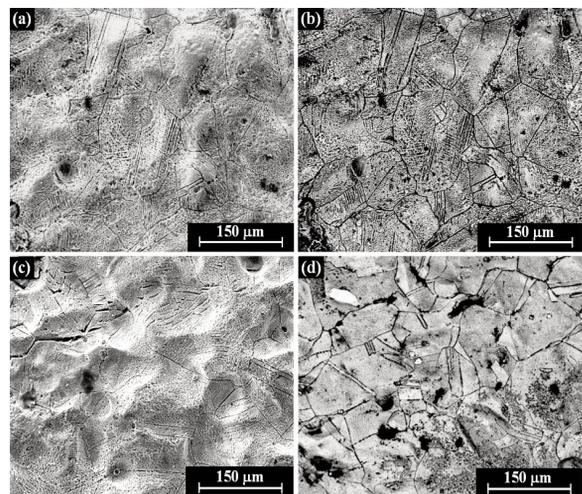
Figure 9. SEM images of the sheet (P-section, polished): (a) equiaxed α grains and annealing twins (SE mode); (b) α grains, annealing twins and slip bands (BSE mode); (c) α grains, cracks, twins and slip bands (SE); and (d) equiaxed grains and annealing twins (BSE)
