INVESTIGATION OF THE ENERGY EFFICIENCY OF THE MILITARY MUSEUM BUILDING BY INFRARED THERMOGRAPHY

Slavica S. Ristić, GOŠA Institute, Belgrade,
Suzana R. Polić-Radovanović, CIK – Central Institute
for Conservation, Belgrade,
Bore V. Jegdić, GOŠA Institute, Belgrade

FIELD: Energy Efficiency
ARTICLE TYPE: Professional Paper

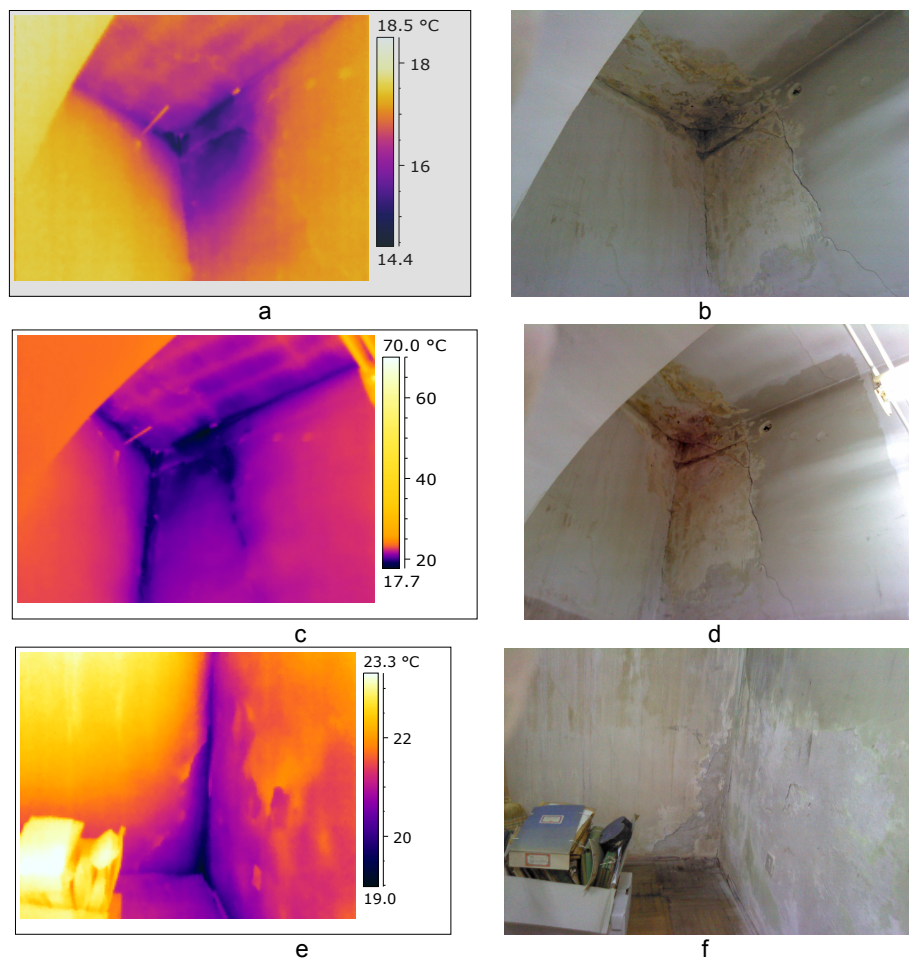
perature falls to 10.8°C. The analysis of the thermogram shows that optically visible stains on the wall are larger than the area of the currently active moisture. In this corner, an electrical wire is surrounded by a wet wall (Fig.1).

The next thermographic inspection was done at the end of November, two days after a heavy rain, at the following conditions: $T_{ou} = 5^{\circ}\text{C}$, $T_{in} = 11^{\circ}\text{C}$, weather conditions: Overcast, no wind (Figs.1c and 1d). Active, visible moisture and leakage through the building originated from the terrace above this part of the room, covering the big wall area.

Figure 1 – Moisture in the far left corner of the library in relation to the front door, a,b-thermogram and the photo in the October test, c,d-thermogram and the photo in the November test, e and f- the lower part of the same corner during the second test

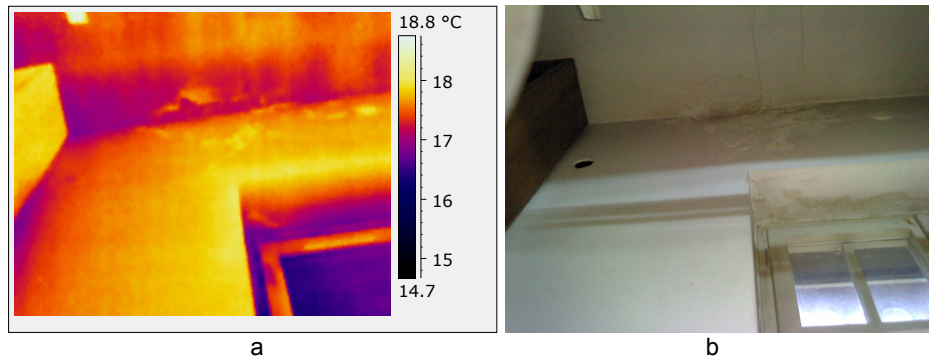
The moisture was not detected in the wall above the first (from left) window (Fig.2a). Poor sealing of the windows was recorded. Brighter parts of the thermogram represent the parts of the wall with a layer of plaster disbonded. The air under the plaster is a good insulator; therefore, these parts were warmer (brighter) than the rest of the wall.

Figure 2 – Part of the wall above the first left window
Slika 2 – Deo zida iznad prvog levog prozora

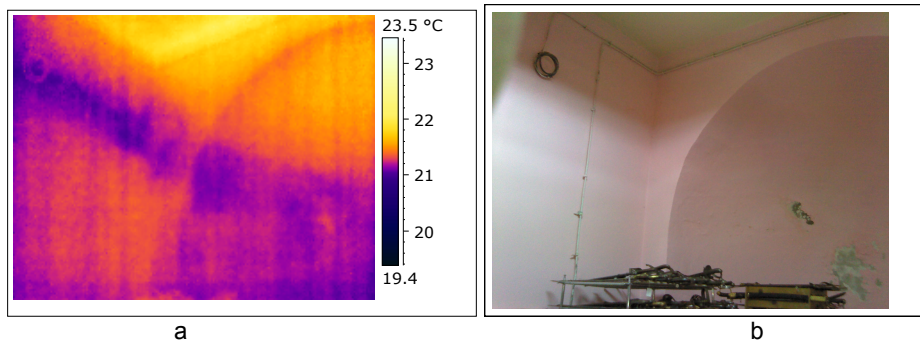
In the weapons depot, the temperature during the October test was $T_{in} = 21^{\circ}\text{C}$, humidity 60%. Under these conditions, the dew point would be when the temperature reaches 13°C . The concrete bridge (Fig.3a) is colder than the rest of the wall. It is a potential place for the condensation of moisture.

Figure 3 – Visible cold zones and the concrete beam in the weapons depot
 Slika 3 – Vidljive hladne zone i betonska greda u depo naoružanja

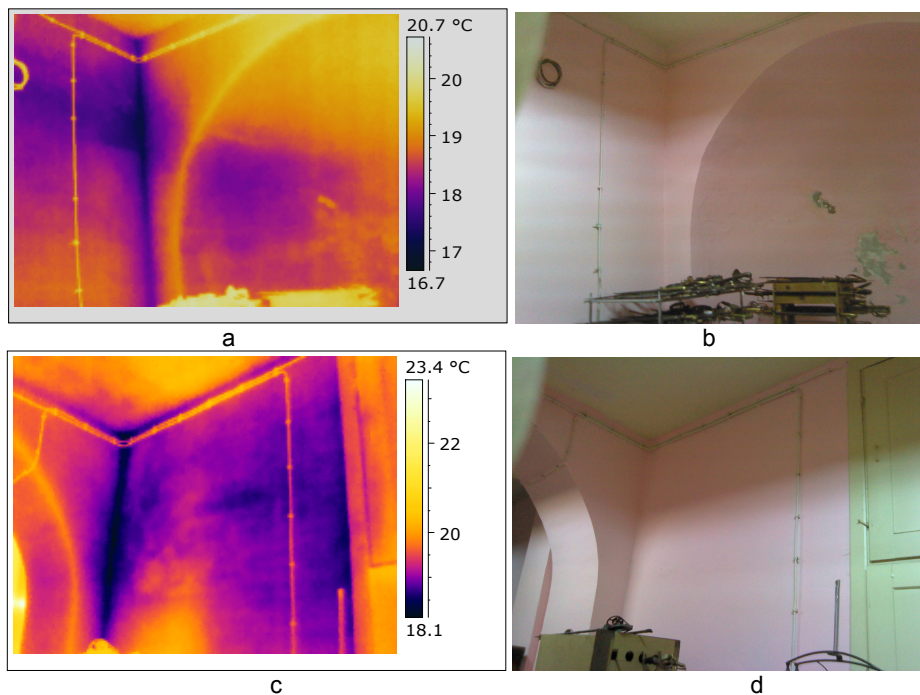
The second set of thermographic tests, performed two days after a heavy rain, ($T_{ou}= 5^{\circ}\text{C}$, $T_{in}= 20^{\circ}\text{C}$), displays the extent of the moisture intrusion in the weapons depot (Fig. 4). In the upper left corner (Fig. 4a), beside the cold concrete bridge, there was damp penetration since the depot is in the basement, below the ground level. A similar case is in the right corner, too. The electrical installations are visible as bright lines on both thermograms.

Figure 4 – Thermograms and the photos of the weapons depot with visible moisture
 Slika 4 – Termogrami i fotografije depoa naoružanja sa vidljivom vlagom

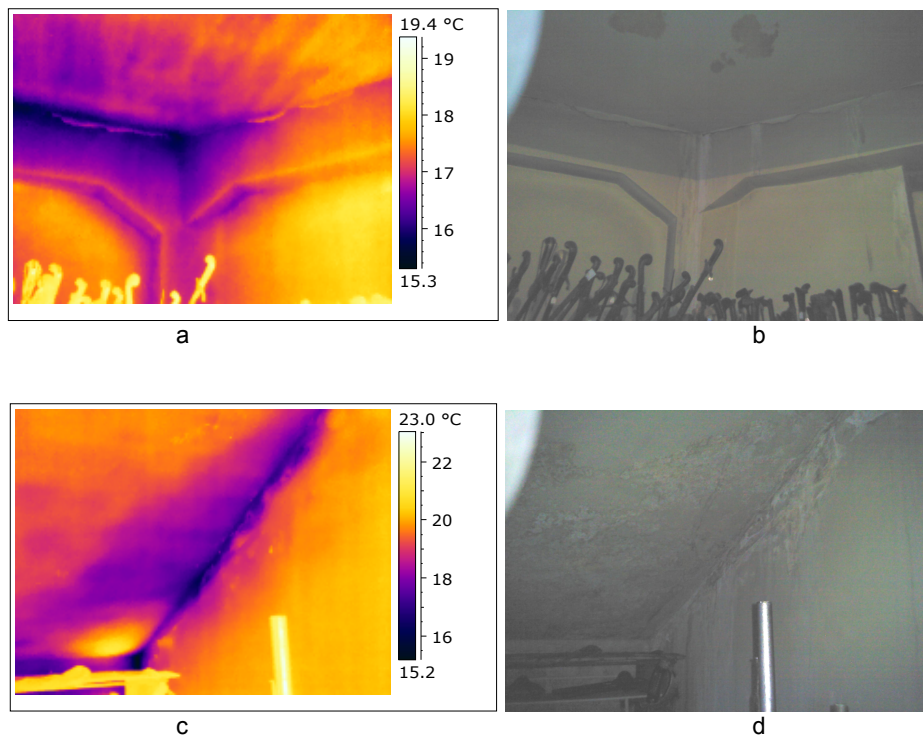
The presence of moisture in the depot where old metal artifacts are kept, contributes to the acceleration of corrosion and deterioration of exhibits. The thermographic inspection shows that moisture is penetrating from the roof and from the poor leakage location (Fig. 5).

Figure 5 – Some details of the old metal artifacts depot
Slika 5 – Nekoliko detalja depoa sa zbirkom starih metalnih eksponata

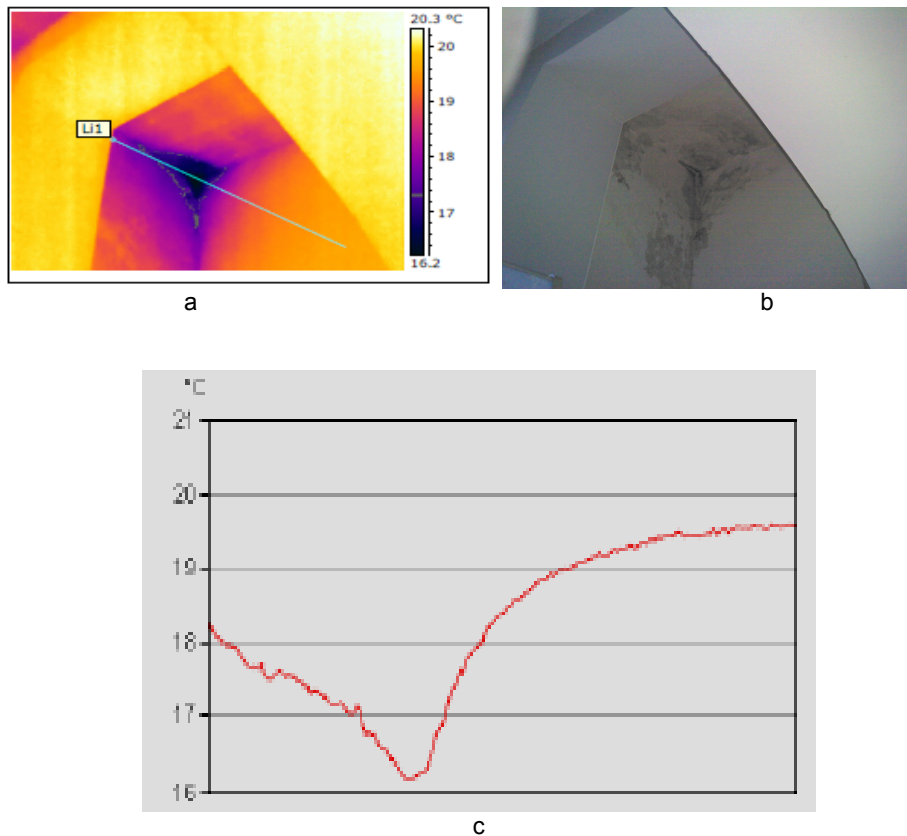
Moisture intrusion was detected in most of the inspected museum depots and other rooms,. The active moisture was detected in the depot of gifts, too. During the thermogram recording, the measured temperature was $T_{in}=20.8^{\circ}\text{C}$ and moisture was 53.7%. If the measured moisture retains, and the temperature lowers to $T_{in}= 10.8^{\circ}\text{C}$, then the condensation of moisture from the air appears on the walls. Figs. 6 show a part of the ceiling in the right upper corner with a-thermogram, b-digital photo and c-diagram of the temperature changes along the line tool.

Figure 6 – Part of the gifts depot
 Slika 6 – Deo depoa sa zbirkom darova

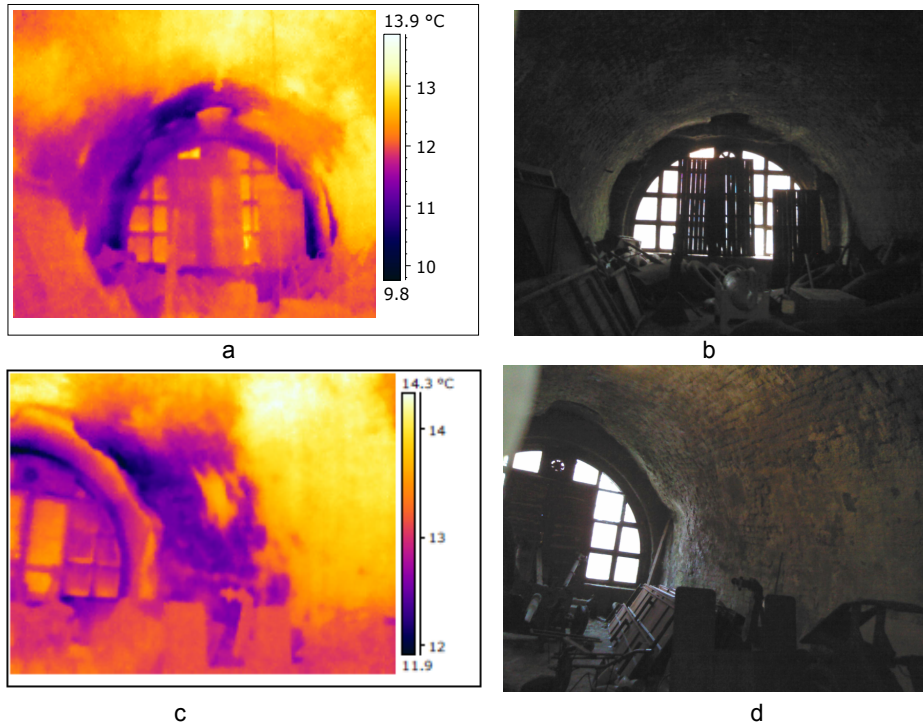
Fig. 7 shows the presence of moisture in the museum Casemates. The inspection was performed under these meteorological conditions: $T_{ou}=19^{\circ}\text{C}$, $T_{in} = 15.4^{\circ}\text{C}$, humidity of 67%, dew point temperature 9.3°C . Metal objects have been kept in the dungeons of the Military Museum at Kalemegdan, and the present moisture has a beneficial effect on the development of corrosion (Polić-Radovanović, Ristić, Jegdić, Nikolić, 2010), (Polić-Radovanović, 2010, p.161), (Jegdić, et al, 2011, pp.50-56), (Jegdić, et al, 2012, pp.169-182).

Figure 7 – Moisture in the museum Casemates, a,b – the first casemate
 c,d – moisture in the second one
 Slika 7 – Vлага u muzejskim kazamatima, a, b – prvi kazamat,
 c,d – vлага u drugom kazamatu

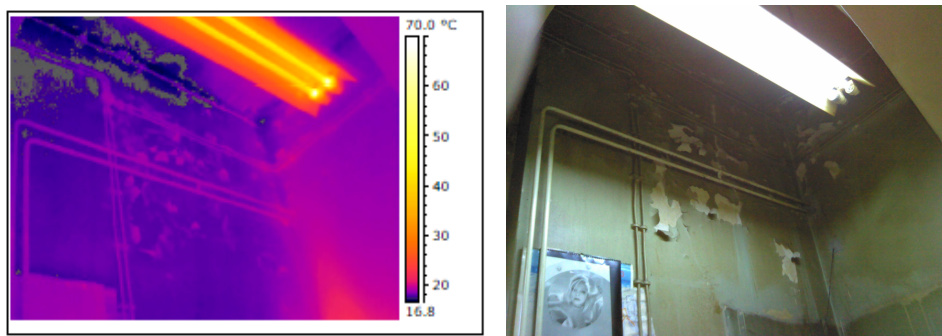
The workshop for metal conservation was investigated by thermography. The cold and damp workshop walls are presented in Fig. 8, (a thermogram-, b-digital photo, c-isotherm indicating that moisture covered the area).

Figure 8 – Appearance of the cold wall in the workshop for metal conservation
Slika 8 – Izgled hladnog zida u radionici za konzervaciju metalnih eksponata

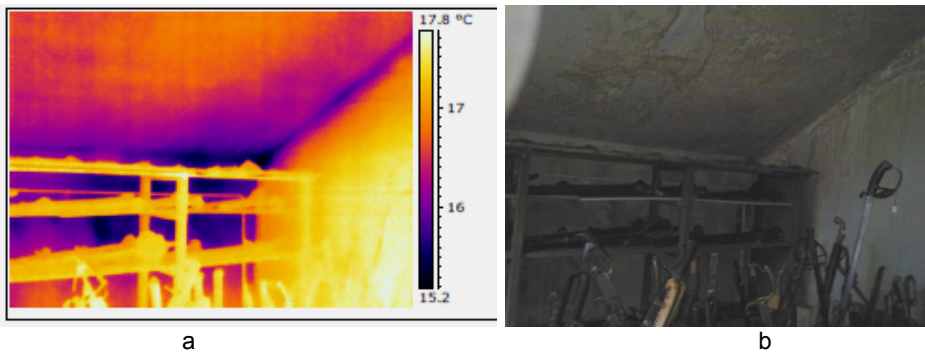
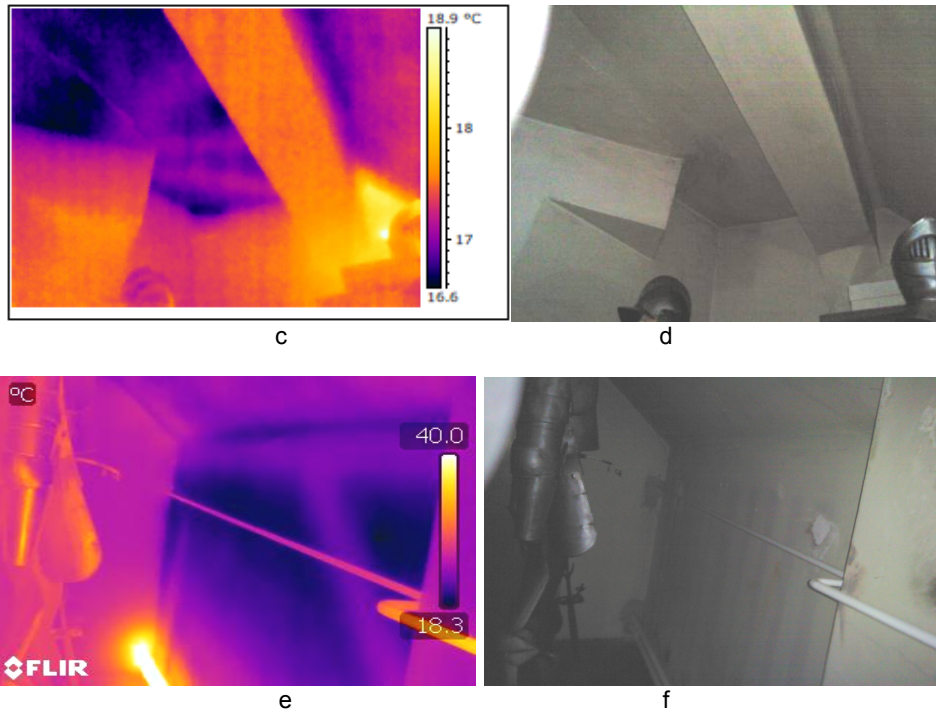
The collection of old metal artifacts is stored in the depot where the wall and the roof have poor thermal insulation. Figs. 9a to 9c show the

right corner of the depot. There are stains, but currently there is no moisture in the walls. The wall behind the shelves which restrict the access for thermographic inspection is colder than the other walls because of poor thermal insulation. The part of the door and the poor roof insulation are shown in Figs. 9c and 9d. The same situation is in the depot with the collection of non-European weapons.

Figure 9 – Depot of old metal artifacts, a,b – side wall, c,d – roof, e,f – wall of the depot with the collection of non-European weapons
 Slika 9 – Depo zbirke starih metalnih eksponata, a,b-bočni zid, c,d – krov, e,f – zid depoa sa zbirkom neevropskog naoružanja

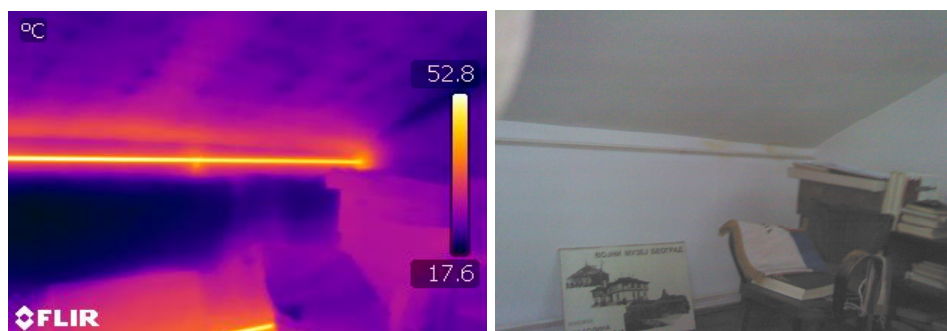
The thermal insulation is also very poor in the museum offices. Fig. 10 shows the thermogram and the photo recorded in the museum office located in the attic.

Figure 10 – Office in the attic, poor thermal insulation
 Slika 10 – Kancelarija u potkrovlju, loša termalna izolacija

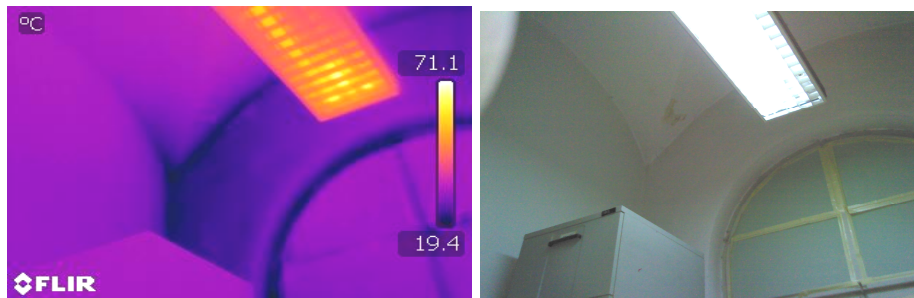
The thermographic tests of the photo collections depot confirm that there is no potential leak, penetration or condensation of moisture, only poor thermal insulation (Fig.11).

Figure 11 – Poor thermal insulation in the photo collections depot.
Slika 11 – Loša termička izolacija u depou sa zbirkom fotografija

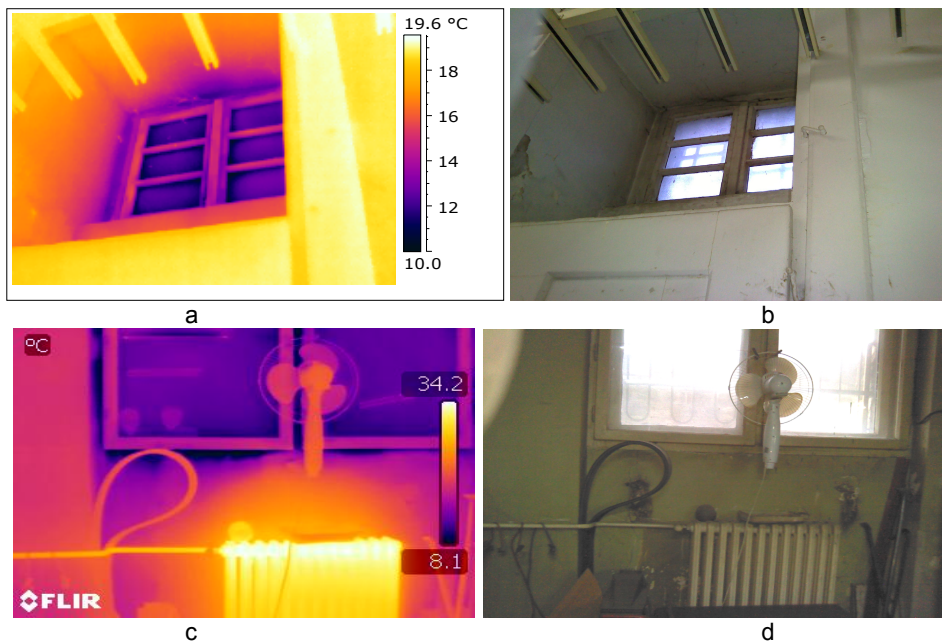
Visual and infrared images of some windows and doors of the museum building show the poorly sealing windows, with an air leakage. This is a very important malfunction for the energy efficiency of the building (Fig 12).

Figure 12 – Poorly sealing windows, cold air leakage, a,b – banners depot and c,d – in the workshop for metal conservation
Slika 12 – Lošo zaptivanje prozora, prodor hladnog vazduha, a,b – depo sa zbirkom ratnih zastava, c,d – radionica za konzervaciju metalnih eksponata
