# THE RESEARCH OF REINFORCED CEMENT LINER FOR RECONSTRUCTION OF WATER SUPPLY AND SEWER PIPES

Elena Makisha

Moscow State University of Civil Engineering, 26, Yaroslavskoye shosse, Moscow, Russia

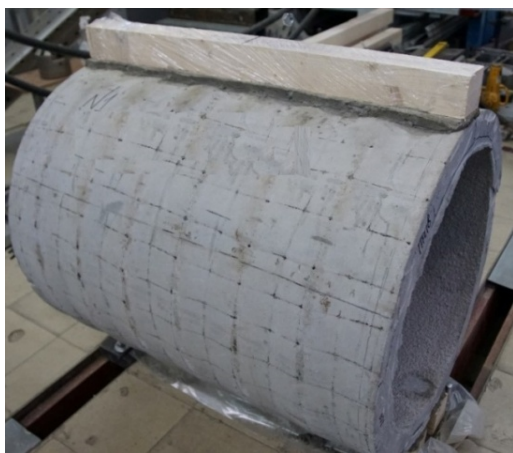
Figure 1. Photo of the specimen #1

There were two specimens (Figs.1 and 2) manufactured for the research to imitate the cylindrical segment of inner cement coating of a host pipeline. The mortar liner specimen was reinforced with mesh frame of composite fiber (fig. 3 a, b).

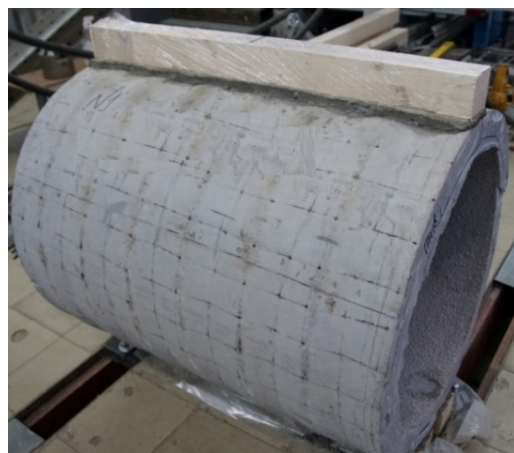
Figure 2. Photo of the specimen #2

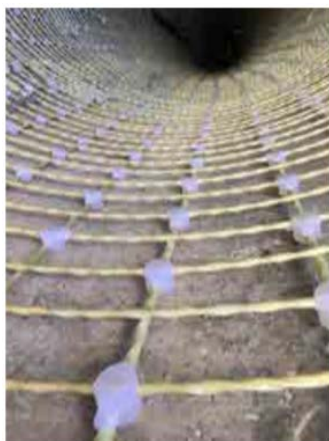
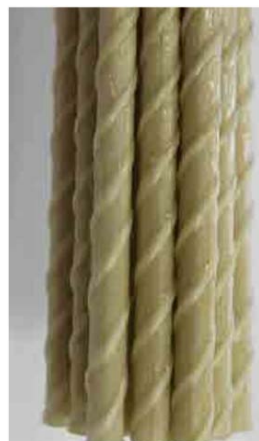
Figure 3. Composite reinforcement: a – reinforcement mesh frame; b – specimen of reinforcement

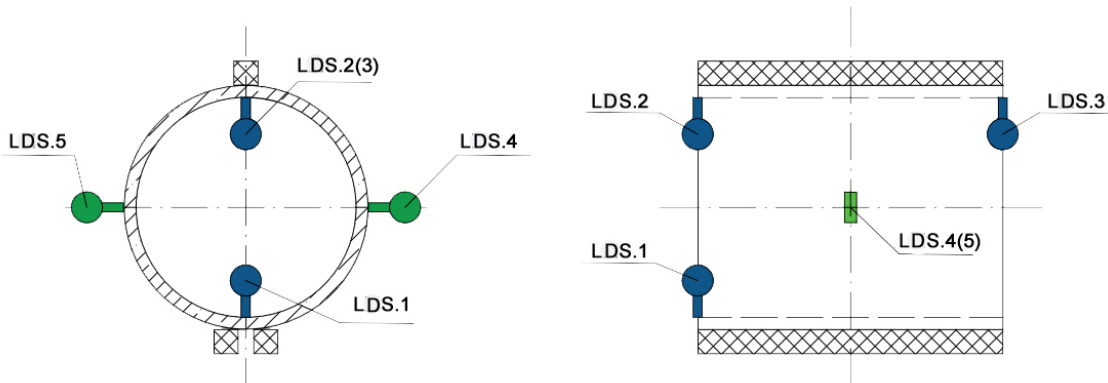
Figure 6. Location of linear displacement sensors (LDS): LDS.1, LDS.2, LDS.3 – sensors of linear vertical displacements of the specimen walls; LDS.4, LDS.5 – sensors of linear horizontal displacements of the specimen walls

Figures 6 shows the loading scheme of the specimen and the location of the linear displacement sensors, which were used to determine the deviation of the geometric dimensions relative to the initial state. The appearance of the specimens after the test is shown in figures 7 and 8.

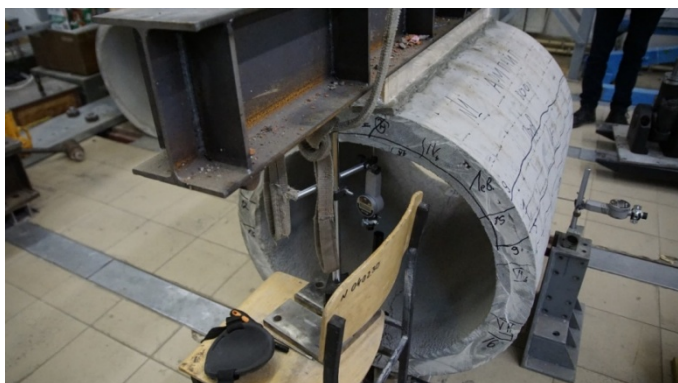
Figure 7. Specimen #1 after test

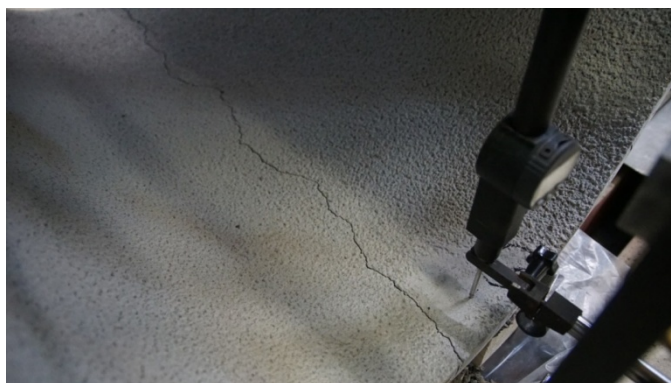
Figure 8. Crack of the width of 2mm inside the specimen #2

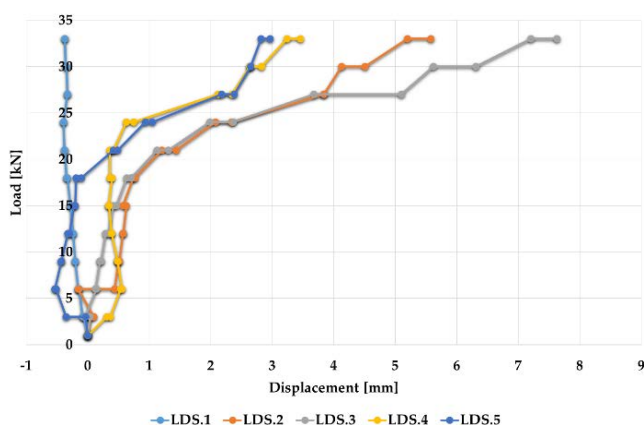
Figure 9. Diagram "Distributed load-displacement" for specimen #1

Figures 9 and 10 summarize the dependencies of displacement related to applied load for specimens #1 and #2, respectively. For specimen #1 (Fig.9), the measured displacement did not exceed 0.5 mm until the load reached the value of 15 kN. The next step of loading (+5kN) resulted in significant (5-6 times) growth of displacement, which was measured by sensors placed on the crown of the coating element. This means that the compressive strength of the cement component of the coating has been reached, and in the absence of reinforcement, this would lead to a loss of the bearing capacity of the entire coating element. Increase of the load until 30 kN led to the fluidity of composite reinforcement resulted in the crack opening, and consequently in the loss of bearing capacity.

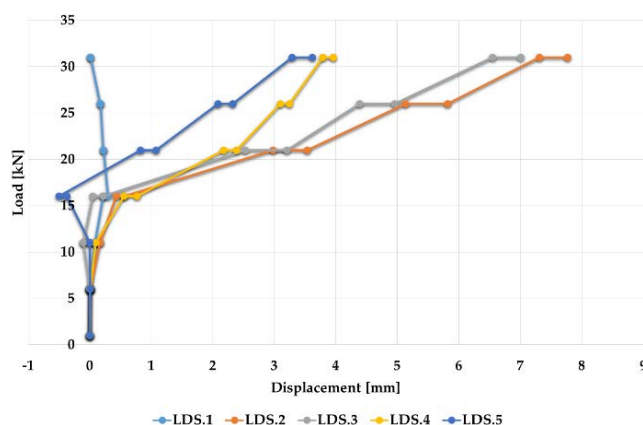
Figure 10. Diagram "Distributed load-displacement" for specimen #2

For specimen #2 (fig.10), the measured displacements did not exceed 0.5 mm until the load reached the value of 15 kN. The next step of loading (+5kN) showed only slight (double) growth of displacement. The further step of loading until 25 kN showed another double growth of displacement. Under the load of 33 kN, the loss of bearing capacity was reached due to the opening of cracks that meant the fluidity of composite reinforcement. For both specimens, displacements values measured under maximum loads were comparable. Obtained results correspond to existing practice, when a crack load and ultimate load relate to each other with a safety factor of 1.5 [25].

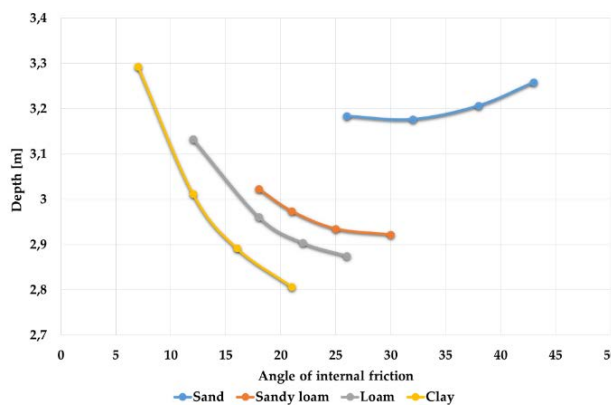
Figure 11. Determination of the height of the soil layer above the crown of the coating element

As it can be seen, in height of the sand soil layer is approximately 3.2 m regardless of the sub-type of the soil. On contrary, the sub-type of the clay soil may have a significant influence on conditions of coating application, with the soil height range between 2.8 and 3.3 m. For loam and sandy loam, the intermediate results are witnessed.
