Pseudotumor as adverse local tissue reaction due to implant corrosion

Ognjen B. Vukadin*, Jelena M. Džudović†, Aleksandra M. Repić‡,
Zoran Lj. Baščarević*

*Institute for Orthopedic Surgery “Banjica”, Belgrade, Serbia; †Military Medical Academy, National Poison Control Center, Belgrade, Serbia; ‡Institute of Forensic Medicine, Belgrade, Serbia

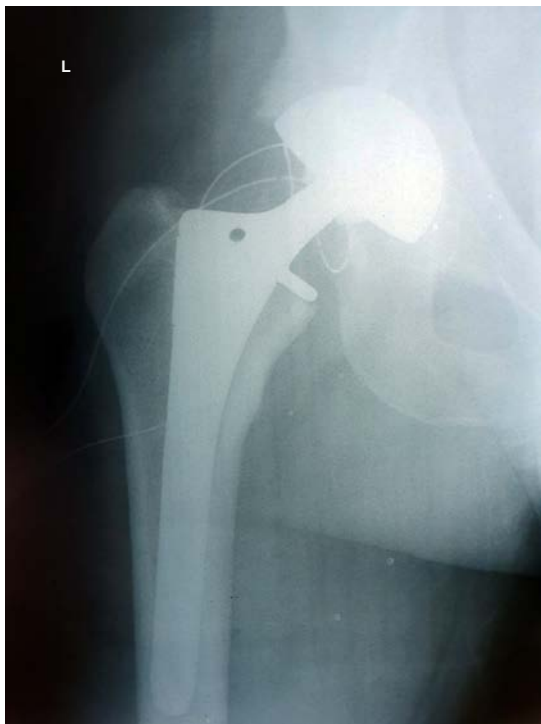
A 57-year-old man has been admitted to the hospital because of pain and pelvic mass. Initially, total hip replacement was performed at the age of 50 due to avascular necrosis of the hip and consequent degenerative hip disease. Initial total hip replacement was performed in 2005 with ceramic-on-ceramic (CoC) coupling (Zimmer Trilogy AB acetabular component, Fiber Metal Midcoat stem, Biolox forte alumina, ceramic head 28 mm) (Figure 1).

Fig. 1 – Postoperative X-ray showing unremarkable implant position.

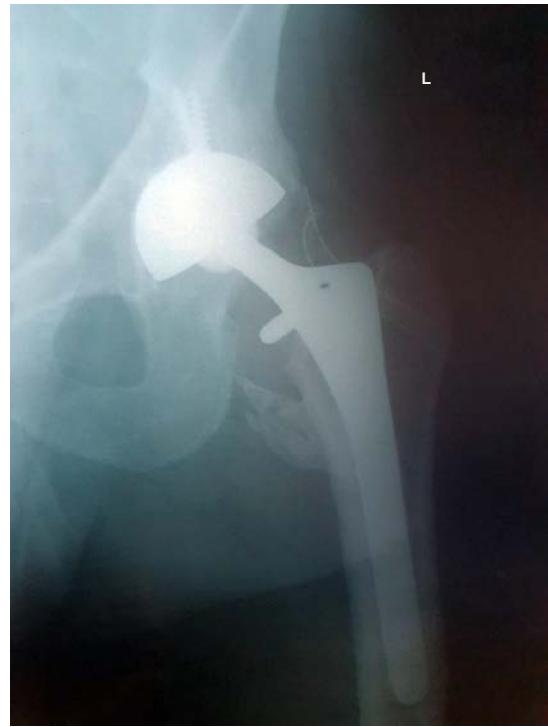
In 2007, two years after index surgery, atraumatic breakage of the ceramic acetabular insert occurred. The revision was performed by replacing the ceramic components solely (Zimmer Trilogy AB acetabular component, Fiber Metal Midcoat stem, Biolox forte alumina, ceramic head 28 mm) (Figure 2). No significant debris was encountered at that time.

Fig. 2 – X-ray after first revision surgery showing replaced ceramic insert and modular head with retained initial acetabular and femoral components.

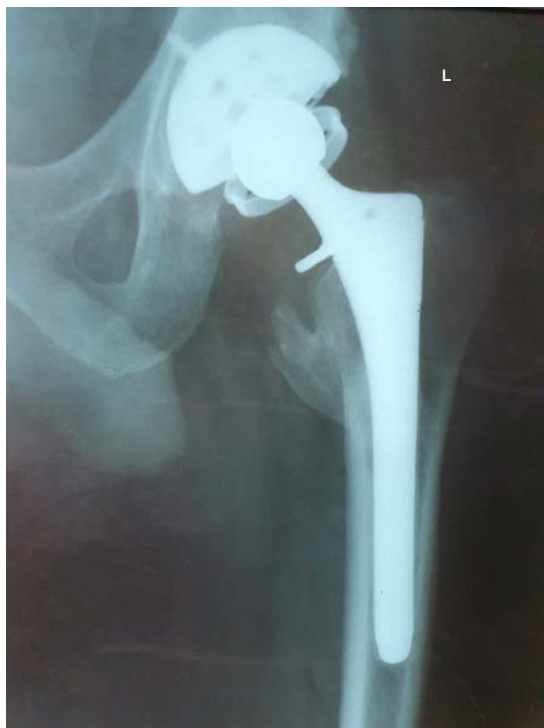
Another revision was done by the same surgeon using the previous incision through a posterolateral approach. The acetabular component was revised with a constrained liner, with metal-on-polyethylene (MoP) coupling with titanium aluminum vanadium (TiAlV) alloy consisting of CoCr head and polyethylene liner with stainless steel ring [Zimmer Trilogy acetabular component, ultra-high molecular weight polyethylene (UHMWPE), CoCr ceramic head 28 mm]. No damage to the femoral stem and neck was notified and mentioned in the report (Figure 4).

Fig. 4 – X-ray after revision hip arthroplasty with acetabular replacement and constrained polyethylene liner insertion.

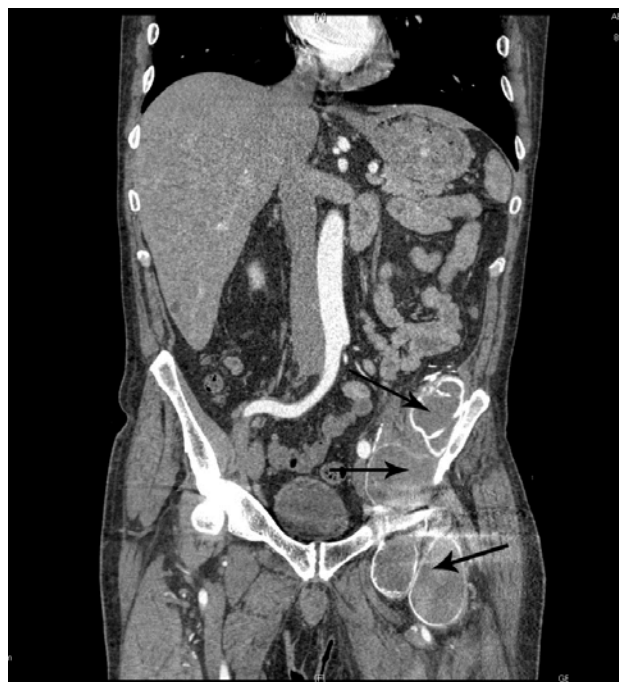
In 2011, the patient started to complain about pain and discomfort in the inguinal and gluteal region with ataxic episodes and hearing and seeing impairment, and a constant feeling of fatigue. The symptoms were evolving rapidly and the patient was admitted to our hospital for a large pelvic and abdominal mass. These symptoms were accompanied by elevated blood Co and Cr levels – 133.9 $\mu\text{g/L}$ and 40.3 $\mu\text{g/L}$, respectively. Multidetector computed tomography (MDCT) showed large intra-abdominal masses and collections (Figure 5).

Fig. 5 – Large pseudotumor mass (279 × 94 × 59.3 mm) depicted on multidetector computer tomography (arrows).

Due to a usual absence of pain in the affected hip, differential diagnosis of the ALTRs could be difficult and should consider soft tissue problems such as psoas tendonitis and bursitis, referred pain from spinal disorders, and inguinal or abdominal hernias. Multidetector computer tomography scan could be helpful in the evaluation of the component position; magnetic resonance imaging could be helpful in the evaluation of pelvic and abdominal masses and fluid collections. Bone scintigraphy can indicate infection or loosening.

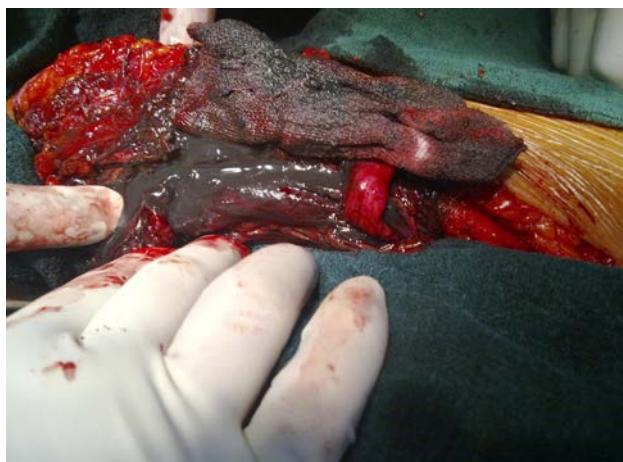
In December 2012, he was prepared for surgery, and multiple lobulated tissue formations filled with dark fluid were removed from the inferior pelvic wall and retro-abdominal musculature, which was infiltrated by metallic debris and dark greyish fluid (Figure 6).

A subsequent pathohistological examination confirmed metallosis. The laboratory markers of inflammation were slightly elevated – C-reactive protein 7.7 mg/L [reference value (RR) up to 5 mg/L], erythrocyte sedimentation rate 2 mm/h (RR up to 10 mm/h), fibrinogen 3.5 g/L (RR 2–4 g/L).

Fig. 6 – Part of the excised intrapelvic mass.

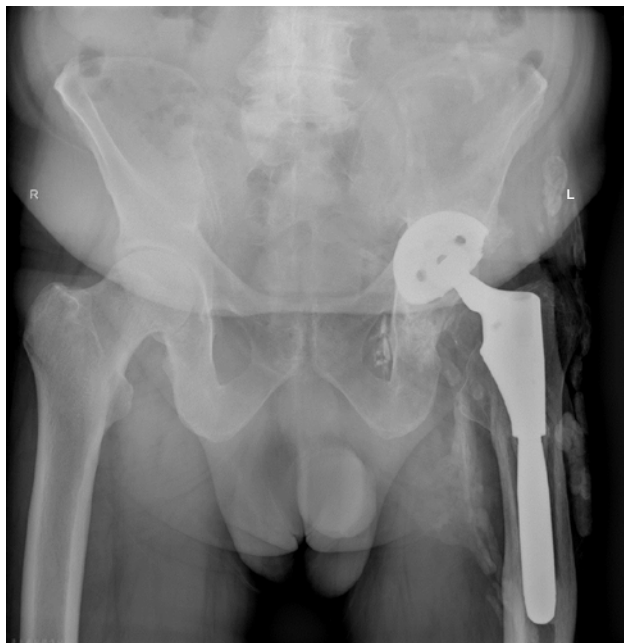
In July 2013, seven months after the removal of pseudotumor masses and explantation of endoprosthesis, another revision was performed, and a modular revision stem was implanted with a ceramic head and polyethylene liner coupling (Zimmer Modular Revision stem, Zimmer Trilogy acetabular component, and UHMWPE liner, ceramic head 32 mm) which consists of a stem and shell made of Ti/Va/Al alloy with a polyethylene acetabular insert and ceramic modular head (Figure 8).

Fig. 8 – X-ray image after final revision with residual metal particles in the periarticular tissue resembling heterotopic ossification.

The patient recovered to unassisted walking. His hearing and sight loss did not recover. At the last follow-up in 2021, his hip was pain-free and functional, and serum Co and Cr levels were within normal values (1.5 µg/L and 4.2 µg/L, respectively).
