A successful retrieval of stripped outer coating of J-tip diagnostic guidewire from the left popliteal artery during elective coronary angiography

Miodrag Damjanović*, Sonja Šalinger-Martinović*, Danijela Djordjević-Radojković*, Goran Koracević*, Vladimir Miloradović†

*Clinic for Cardiovascular Diseases, Clinical Center of Niš, Niš, Serbia; †Clinic for Cardiology, Clinical Center of Kragujevac, Kragujevac, Serbia

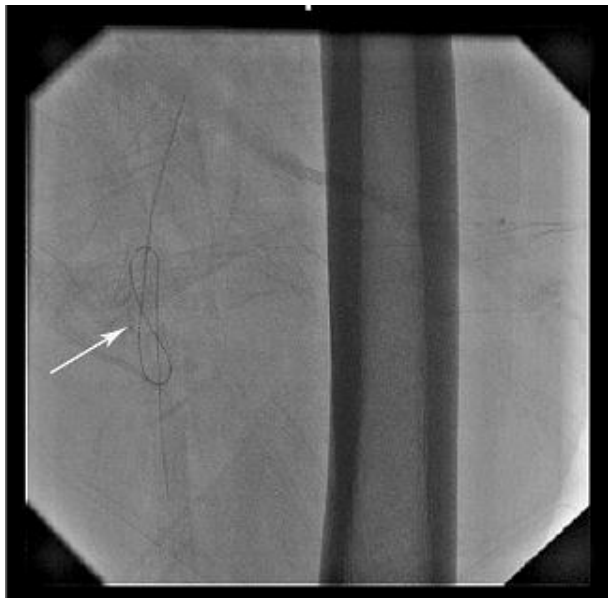
forming a loop, remained in the descending aorta. The looped stripped part of guidewire was immediately tried to catch by the other J-tip guidewire, but unsuccessfully. Very soon, this outer coating of the guidewire carried by the blood stream was entered into the left femoral artery, then into the left popliteal artery. The other arterial sheath was inserted after antegrade arterial puncture into the left femoral artery. The stripped part of the outer coating of the guidewire travelled into the left popliteal artery to the knee level during that time (Figure 1).

Fig. 1 – The stripped part of outer coating of diagnostic J-tip guidewire in the left popliteal artery just at the knee level (arrow).

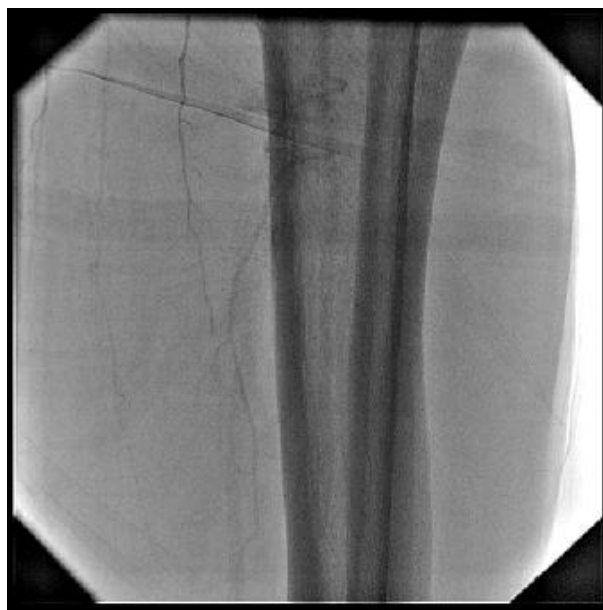
Then a goose neck snare catheter was introduced into the sheath and advanced it into the left femoral artery. After bypassing this stripped part of the guidewire we caught it and extracted it out (Figure 2).

Fig. 2 – The left popliteal artery without outer coating of guidewire.

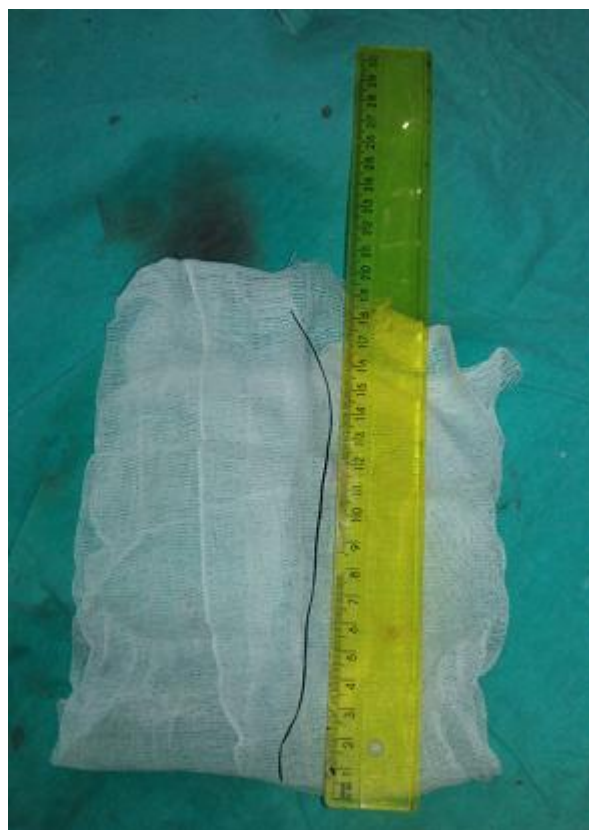
This outer coating was 18 cm in length (Figure 3).

Fig. 3 – Outer coating of guidewire 18 cm in length.
