HIDRAULIC HAMMER EXCAVATOR FAILURE DUE TO SOLID PARTICLE CONTAMINATION

Mitar T. Jocanović^a, Velibor V. Karanović^b,
Andrea V. Ivanišević^a, Darko M. Knežević^b

FIELD: Mechanical Engineering

ARTICLE TYPE: Original Scientific Paper

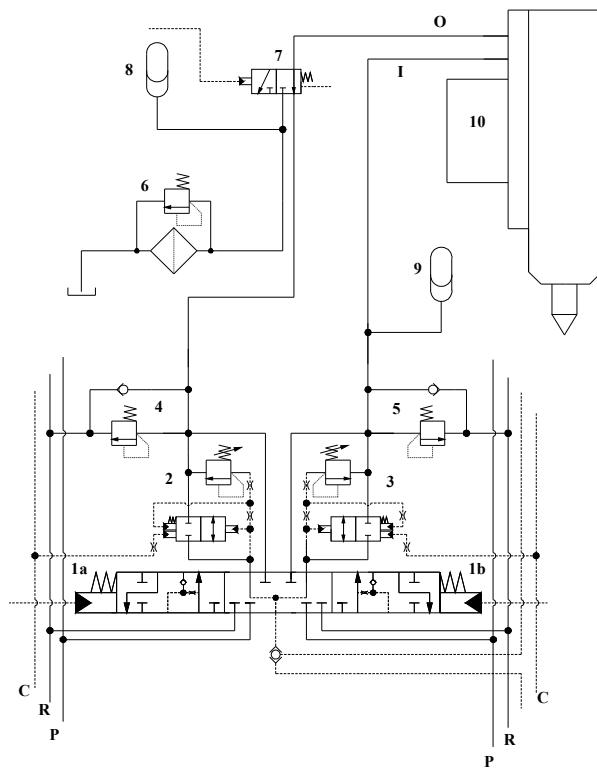
A hydraulic hammer system, shown in Figure 1, receives the working fluid from the pressure line of the central system "P" that is connected with a double piston axial pump with a capacity of 315 l/min. The directional control valve 9/3 (position 1), supplies the hydraulic hammer with the working fluid (position 10) by bringing the control pressure to 1a side of the directional control valve. Through a group of regulating valves (positions 3 and 5) and the pressure line labeled with "I", the oil under pressure supplies the entrance side of the hammer regulating valve (position 10) which further distributes the working fluid according to the phases of hammer operations. The hydraulic accumulator (position 9) decreases the occurrence of hydraulic shocks and pulsations of pressure while the hammer is operating. The oil from the hammer returns directly to the reservoir of the excavator hydraulic system through the return line "O", the directional control valve 7 and the return filter 6.

Figure 1 – A part of the hydraulic scheme for the operation of the hammer
Slika 1 – Posmatrani deo hidraulične šeme čekića

In the excavator hydraulic system, it was visually noticed that, due to poor filtering of the filter block (Figure 1 – position 6) used in the excavator return line, the color of the hydraulic oil changes due to the presence of solid particles of cement dust, which affects the work and reliability of the excavator during the exploitation. Frequent failures of certain components in the system were noticed (of proportional and servo type). In order to prove the assumption relating to inadequate filtering, oil samples were taken from the reservoir (a reservoir volume of 250 liters) of the hydraulic excavator that had been exploited for 950 work hours. By imaging the content of solid particles in oil mass with a device type FCU 2045 HYDAC (Hydac International GmbH., 2010), we obtained the information about the oil purity class (Table 1).

The third cause of contamination is the inadequately designed system of the hammer return line, especially the filter block (Figure 1 - position 6). During the monitoring process, it was noticed that there were some sudden rises of pressure in the filter housing which causes the tearing of the steel filter mesh (Figures 3 and 4) and the penetration of filth in the form of solid particles.

In the hydraulic hammer system, on the return line that takes the oil out of the hammer housing through the filter block (Figure 1 - position 6), the sensors for measuring the pressure (Figure 12) were set up on the measuring points M1 and M2. Based on the measured values obtained through the multy handy diagnostic unit 2045 (Hydrotechnik UK, 2012), it was determined that when the hammer chambers 12, 13 and 16 were unloaded in phase 4 (Figure 2), the pressure dropped in the return line between the inlet (M2) and the outlet (M1) of the filter housing, to the value of $\Delta p=3.5$ bars (Figure 13). According to the manufacturer's recommendation, the pressure relief valve embedded in the housing of the filter was adjusted to open after the pressure had reached the value of $\Delta p_{max}=1.5$ bars. Due to the impact of variable pressure values of $\Delta p=3.5$ bars on the filter cartridge, or more specifically on the mesh and the filtering medium,

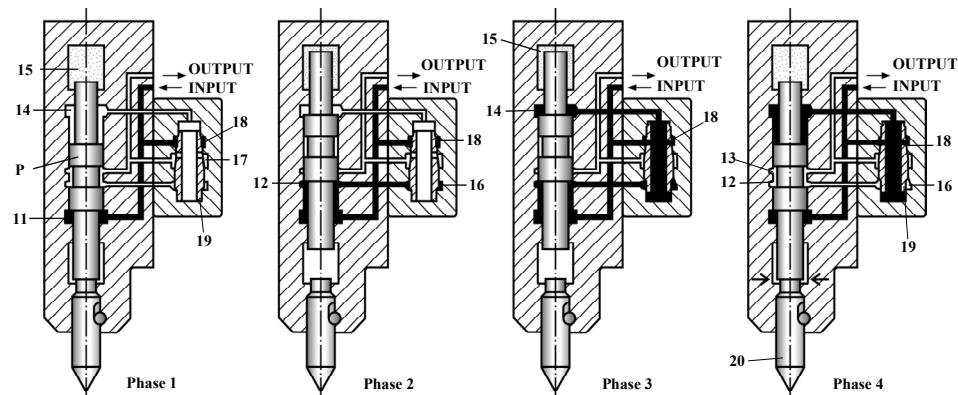
The cross-sectional view (Figure 2) illustrates the operation of the hydraulic hammer which is performed in phases as follows:

- Phase 1: The working piston (P) moves upwards.

The hydraulic oil from the pressure line enters the chambers labeled by positions 11 and 18. The regulating valve (19) is pushed into the lower end position. The hammer working piston moves upwards compressing the gas into the compression chamber (15). The working fluid from chamber 14 is released towards the chamber (17) through the hole in the regulating valve (19), and from there, the oil is sent directly to the reservoir through the return line and the filtering system.

- Phase 2: Setting the regulating valve (19) in the upper position.

When the oil under pressure is pushed into the chamber (11), the hammer working piston moves upwards to the position when the chambers (12) and (16) are filled with oil. At the moment when the pressures are equal due to the difference in the surfaces affected by the pressure, the regulating valve (19) moves into the upper end position joining the chambers (18) and (14).

- Phase 3: The working piston moves downwards

When the chambers (14) and (18) are joined, the force which acts on the upper ring-shaped surface of the working piston in the chamber (14) together with the force created by the compressed gas the storage space of the chamber (15) moves the hammer working piston (P) into the lower working position.

- Phase 4: The working piston hits the chisel

When moving downwards, the working piston (P) hits the chisel (20). At that moment, the middle part of the piston joins the chambers (12) and (13) and, as a result, the chamber (16) on the lower side of the regulating valve (19) unloads as well. The force on the lower side of the regulating valve is smaller than on the upper side causing the regulating valve to return to the lower end position.

Figure 2 – Crossectional view of the hydraulic hammer and the operational phases
Slika 2 – Presek hidrauličnog čekića i njegove radne faze

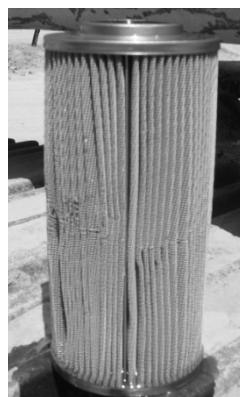
Figure 3 – Filter cartridge embedded in the return line of the hydraulic hammer system

The solution to the problem was achieved in agreement with the excavator supplier who performed an adequate replacement of damaged components in the hydraulic system and fixed the defect in the hammer return line filter block by installing a filter with appropriate fineness of 4 µm(c) and by setting the pressure relief valve in the filter block to the value of 1.5 bars. In addition, the hammer was replaced with another hammer with an appropriate structural design with an improved sealing system that prevented the excessive penetration of solid particles into the interior of the hammer. Also, a secondary filtering system was installed on the main reservoir of the hydraulic excavator system, with the capacity of 10% of the capacity of the main hydraulic pumps. A permanent solution was thus provided for additional filtering of the hydraulic working fluid and for keeping its pureness at the required level.

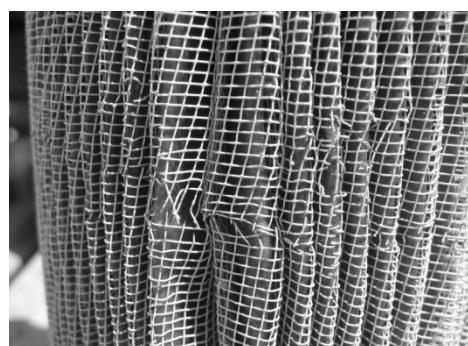
Figure 4 – Visible damage in the steel mesh and the filter medium

enormous force was generated leading to bending and twisting of the medium and steel protection of the filter cartridge. Due to the cyclic loading, the steel mesh became worn out and torn and the filter cartridge medium was splitted (Figures 3 and 4). This phenomenon was also identified after replacing the old filter cartridge with a new one. After only 250 operating hours, the same phenomenon and the damage happened again. Due to mechanical damage, the filter cartridge no longer performed its role and the contaminants that passed through clearances between the seals and the working piston went directly into the reservoir of the hydraulic system.

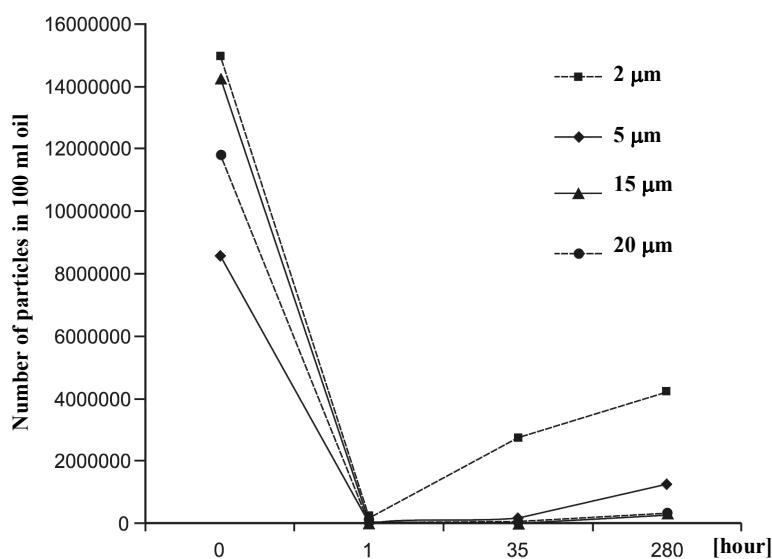
As it can be noticed, the content of contaminants in the form of solid particles in the working fluid increased from satisfying purity class NAS 7 to unpermitted class NAS 10 for a very short period of operating time (35 hours) of the excavator in the extremely contaminated environment (cement industry environment). After 280 operating hours, the oil purity class increased to NAS 13 which represented a class of contamination at unpermitted level (Figure 5).

Figure 5 – Increase in the oil contamination level in 280 operating hours
Slika 5 – Povećanje kontaminacije ulja za 280 radnih časova

Since the excavator was within the warranty period, there was not any possibility to make any change on the hydraulic excavator system in agreement with the servicing staff. The servicing staff insisted that both oil and filters were supposed to be replaced even before the prescribed terms (prescribed replacement of filters after 1000 hours; changing oil after 5000 operating hours), ignoring the presented observations and reports relating to the operation and contamination of the working fluid in the hydraulic excavator system. It is also important to mention that during 1230 hours of the excavator operation, there were three replacements of filters in the hammer return line and one complete change of oil at 950 working hours.

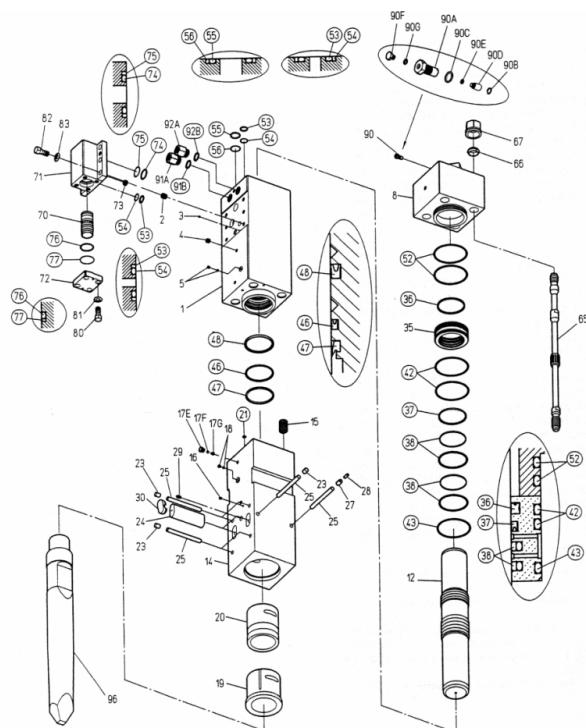
Due to a poor design of the hammer sealing system, where there is only one seal for dust removal (Figure 6 – position 47), a great quantity of solid particles from the atmosphere of the cement industry work environment penetrated the housing of the hammer (Figure 6 – position 1). Solid particles that penetrated the interior of the hammer were washed down by the working fluid and sent to other parts of the hydraulic system, all the way to the reservoir, and after that the pump sent them again to the executive part and other components of the excavator hydraulic system. In this way, the level of contamination cyclically increased in the working fluid.

Due to the penetration of solid particles into the housing, damage occurred in the form of metal particles, as in Figure 7 which presents the interior of the hammer housing (Figure 6 - position 1) with the products of wear that occurred as a result of primarily abrasive wear and partially due to vibration. Figure 8 shows an enlarged image of the housing with the presence of particles and Figure 9 shows the assembly of the piston and the housing with the presence of accumulated solid particles after disassembling the hydraulic hammer. In the presented housing (Figure 9), there is a driving part of the hammer piston (Figure 6 - position 12) which is also presented in Figure 10 with visible traces of abrasive wear resulting from the performance of solid particles from the environment. Due to

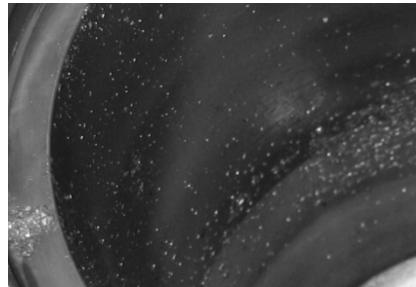
Figure 8 – Enlarged image of the housing with the mass of metal particles
Slika 8 – Uvećan prikaz kućišta sa metalnim česticama

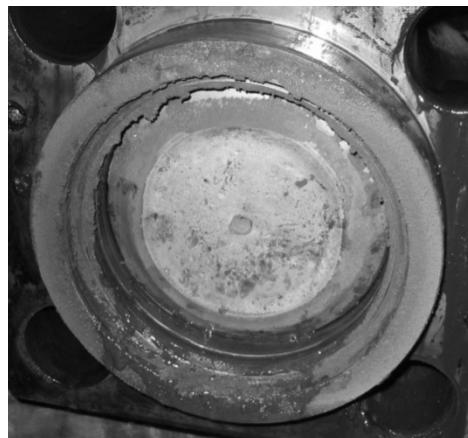
the presence of contaminants, significant damage is visible on the hammer piston in the form of longitudinal scratches that occurred as a result of the abrasive impact of solid particles present in the oil and vibrations that occurred during the operation of the hammer.

Figure 9 – The assembly of the housing and the piston of the hammer with solid particles
Slika 9 – Sklop kućišta i klipa hidrauličnog čekića sa vidljivim čvrstim česticama

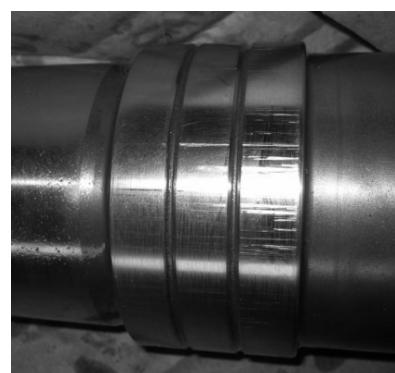
Figure 10 – Abrasive damage on the hammer piston
Slika 10 – Abrazivna oštećenja na klipu čekića

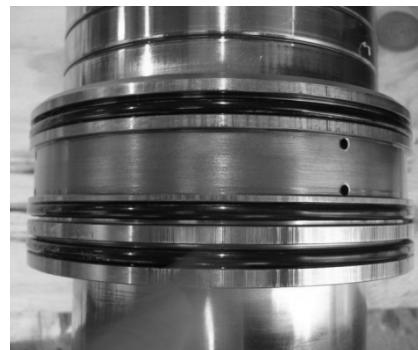
Solid particles present in the working fluid also caused the abrasive wear damage on the piston of the hammer regulating valve (Figure 6 – position 70) and it is shown in Figure 11.

Figure 11 – Abrasive damage of the regulating valve piston
Slika 11 – Abrazivna oštećenja na klipu regulacionog ventila

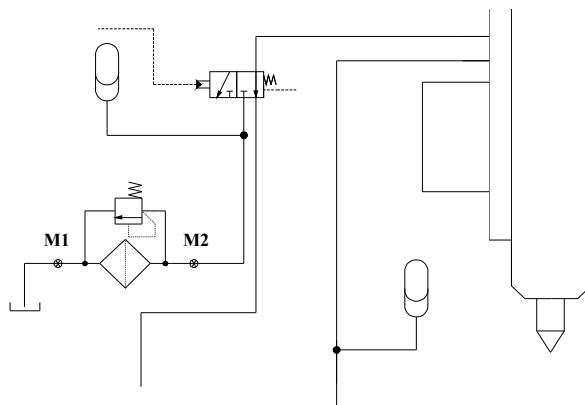
Figure 12 – Measuring points in the filter block of the hydraulic hammer system return line
Slika 12 – Merna mesta na filterskom bloku u povratnom cevovodu hidrauličnog sistema

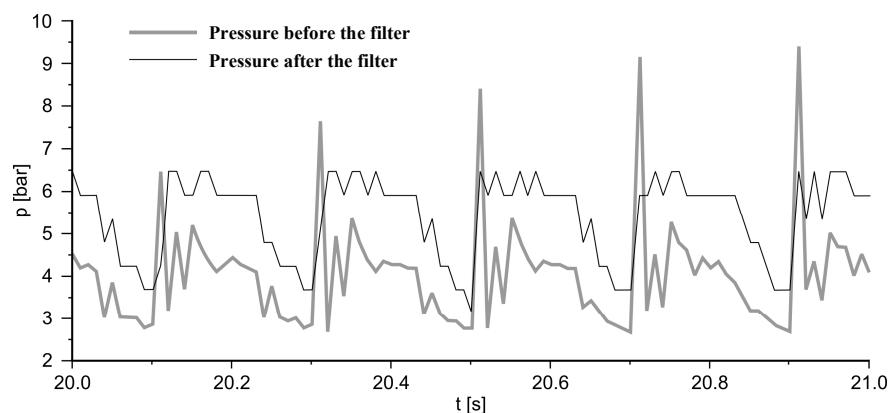
Figure 13 – Changes of pressure values in the filter block of the hammer return line
Slika 13 – Izmerene promene pritiska na filterskom bloku

After the monitoring process, the main cause of damage in the filter cartridge was determined and after that the source of contamination of the whole system was determined as well.
