# Analysis of the application of vibration diagnostics and thermography methods for an early detection of defects in an industrial mixer-gearbox system – a case study

ARTICLE TYPE: original scientific paper

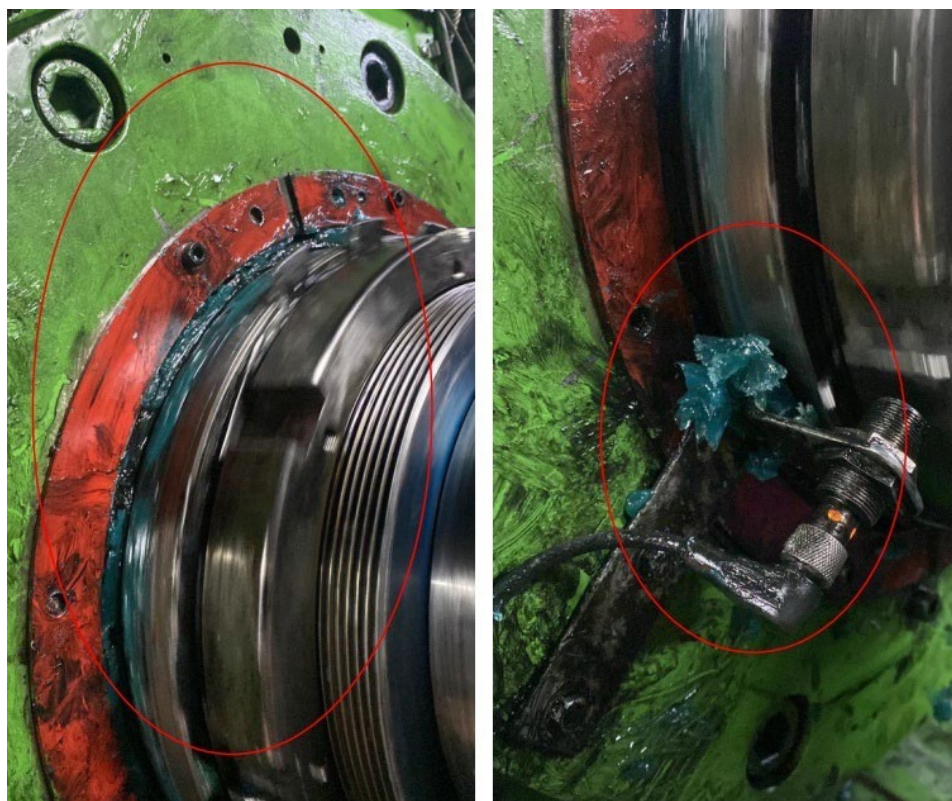
Based on the FFT analysis of the mixer shaft at the output, a minor axial clearance in the bearing at position 1 was detected, attributed to improper bearing installation during assembly. Visual inspection revealed an incorrectly positioned seal on bearing 1, showing signs of wear. Consequently, lubricant leakage from the bearing and the ingress of contaminants into its interior occur, which explains the temperature difference compared to other bearings, given that the seal does not function adequately.

*Figure 12 – Point of the mixer outlet*

From Figure 12, it is clearly seen that there is leakage at the mixer outlet, causing an excessive concentration of heat on the bearing located at the output section of the shaft. Given that lubricant leakage has been identified in the mixer outlet area, a more detailed lubrication analysis of

the bearing at the mixer outlet is necessary. Figure 13 illustrates the lubrication spectrum at the mixer outlet.
