# IMPACT OF DEVASTATING EARTHQUAKES IN CROATIA IN 2020

Mario Uroš\*, Josip Atalić, Marija Demšić, Maja Baniček, Marta Šavor Novak, Alen Kadić

Department of Engineering Mechanics, Croatian Centre for Earthquake Engineering,  
University of Zagreb Faculty of Civil Engineering, Zagreb, Croatia

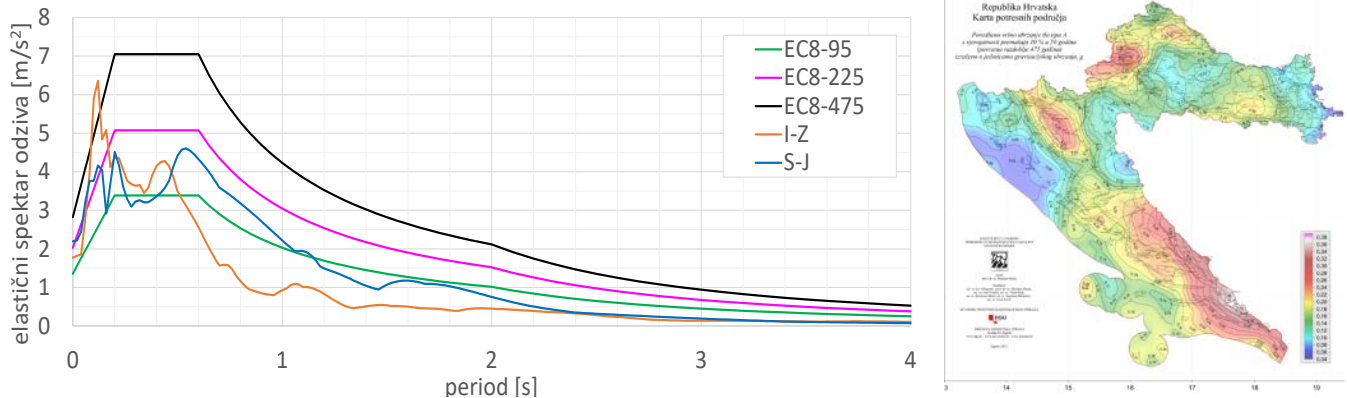
components of the main earthquake recorded at the strong-motion station [7], located 1.75 km from the city center [7] are shown in Figure 4. The figure also shows the elastic Eurocode spectra for different return periods (95, 225 and 475) and soil type C, which corresponds to 5% damped pseudo-accelerations. The peak ground acceleration recorded at this station during the main earthquake was 0.22 g for the north-south (N-S) component and 0.18 g for the east-west (E-W) component. The strong motion spectra show higher amplitudes in the short-period range (<0.5 s), which is very unfavorable for masonry buildings.

Fig. 1. (a) The elastic response spectra of Zagreb earthquake (station near city centre) source: Croatian Seismological Survey, Department of Geophysics, Faculty of Science, University of Zagreb, (b) Seismic hazard map of Croatia for 475 return period [1]
