THE ASSESSMENT AND REPAIR OF THE PRECAST RC STRUCTURE EXPOSED TO FIRE

This paper presents the assessment and repair of precast RC structure exposed to fire in Novi Sad. Detailed visual inspection, which includes described and classified damages and defects of RC columns and beams, is presented in the paper. Control design of the built-in concrete and reinforcement, as well as geodetic survey and conclusion on the state of the structure, are carried out. Two possible repair solutions were analysed.

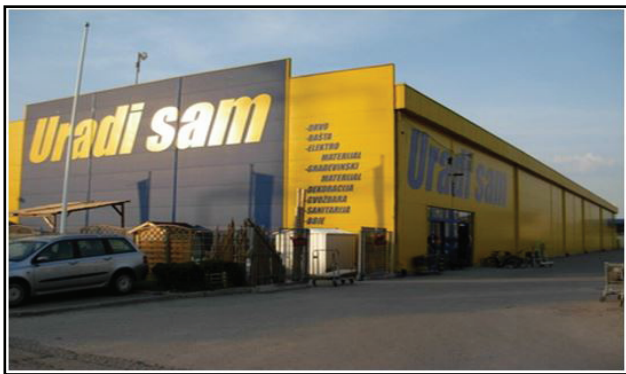
On May 5th 2013. there was a fire in production hall-building "Uradi sam" in Novi Sad. Major interior parts with installations, roof coverings and facade's cladding, as well as complete roof-bearing structure have been destroyed during the fire. RC columns and RC facade beams have suffered serious damages. Object's appearance before and after fire and clearing the ground off, are presented in Figures 1 and 2.

Figure 1: Object's appearance before fire
