ANALYSIS OF NATURALLY ETCHED SURFACE OF BRASS SHEATHING FROM A NINETEENTH-CENTURY SHIPWRECK

The Akko Tower Wreck is entirely the remains of a 25-m-long merchant brig, dated to the first half of the nineteenth century. During the 2015 underwater excavation, a piece of brass sheet was retrieved from the shipwreck and its surface and bulk were examined by metallurgical analyses. The examinations revealed a unique example of almost two hundred years' natural etching, which took place in the sea underwater environment. The surface of the sheet was covered with different copper and zinc oxides, which were identified by XRD analysis. Observation of the naturally etched surface with multi-focal light microscopy and SEM-EDS analysis indicated a microstructure of annealed α -brass, similar to that of its bulk. S-OES chemical analysis of the bulk revealed a composition of 65.0 wt% Cu, 34.4 wt% Zn and 0.6 wt% Pb. Based on the thickness of the sheet and its good state of preservation, it is suggested that it was used as sheathing to protect the hull against marine organisms, and to improve the sailing qualities of the ship. The results provide further information about the Akko Tower shipwreck

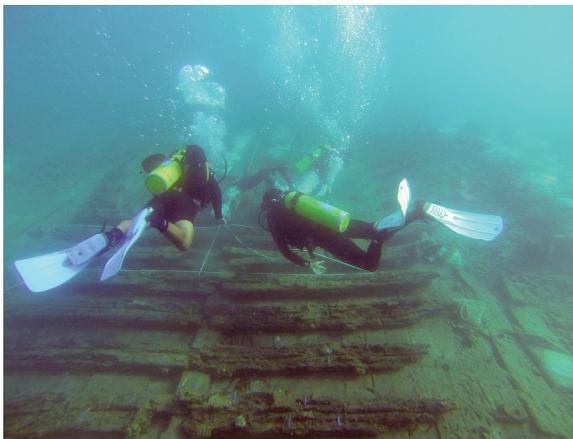
The Akko Tower Wreck (Fig. 1) was discovered during an underwater survey of the ancient harbour of Akko in 1966. It lies at the entrance to Akko harbour, 35 m north of the Tower of Flies, after which it was named. Since this discovery the shipwreck has been surveyed twice, in 1975 and 1981 [7–9]. However, the researchers came to conflicting conclusions regarding the original ship. Following these, four seasons of underwater excavations were conducted in 2012, 2013, 2015 and 2016 by the Leon Recanati Institute for Maritime Studies of the University of Haifa.

The Akko Tower Wreck was found in 4.4 m of water. The shipwreck remains, oriented north-east to south-west, were 17.8 m between its extremities, and maximum 6.4 m wide. Among the hull remains were sections of the keel, rising wood, keelson, hull planks, framing timbers, ceiling planks, and limber boards. Hull components were made of pine (*Pinus*) and oak (*Quercus*) species. It has been suggested that the original ship was a 25-m-long merchant brig, dated to the first half of the nineteenth century, and built under

Figure 1. General view of the Akko Tower Shipwreck (Photo: A. Yurman)
