# **PERFORMANCE EVALUATION OF ROOF-TOP PV SYSTEMS IN THE AREA OF KAVALA NORTH GREECE**

*The continuously growing demand for electricity and the need to develop Renewable Energy Sources (RES), pushed the modern world to develop Photovoltaic (PV) systems. An evaluation of performance of photovoltaic power systems was conducted, aiming to analyze the causes of performance reduction of the systems. During the years 2010 - 2013 was a period which was described as «fever of photovoltaic» systems installation in Greece. There were so blatant manufacturing defects mainly to the roof-top PV systems. Studying their location and construction method, radically different, even in neighboring systems we find that the reflection on the performance conditions are reasonable and easy to understand. This is the reason that leads us to make a research study regarding the performance differences of the roof-top PV systems and the causes of them. Mainly we deal more with the systems of low performance  $\leq 10\text{kW}$ , because they are more economical and interesting. In this paper, a study for the area of prefecture of Kavala, Greece is analyzed.*

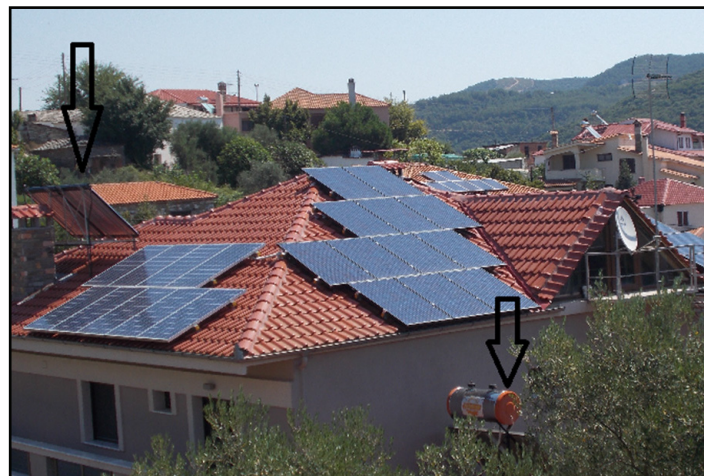
Figure 4: Wrong orientation PV panels

and orientation. Specifically in this case (Fig. 4) we notice the «anarchic» orientation, while the solar panel reveals the correct orientation. This system has an efficiency of 78% average.

In this system (Figure 4), there are 9 panels on the back side of the roof, also the solar panel shows the south direction, and the system's performance in this case is 74% of average. Similar situation is in Fig 5., with the panels oriented in east - west direction with energy yield 80% of average quantity. In some plate roofs, the manufacturer chooses to follow panels parallelogram layout of the roof, sacrificing part of the optimal inclination and orientation. In this category are classified systems where the manufacturer has

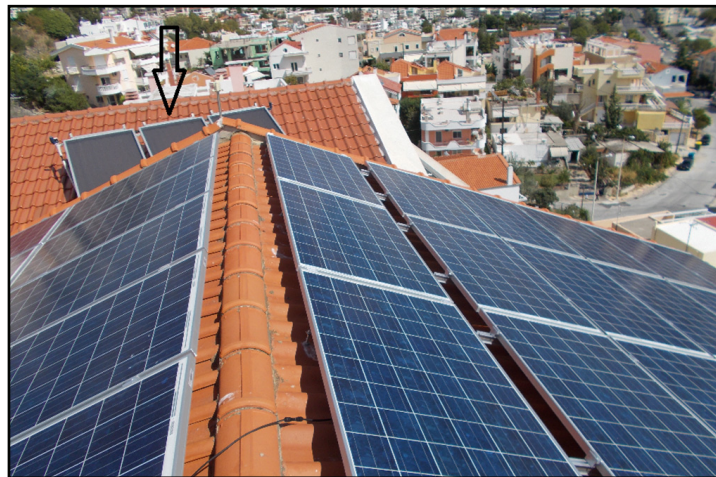
Figure 5: Panels oriented east-west direction

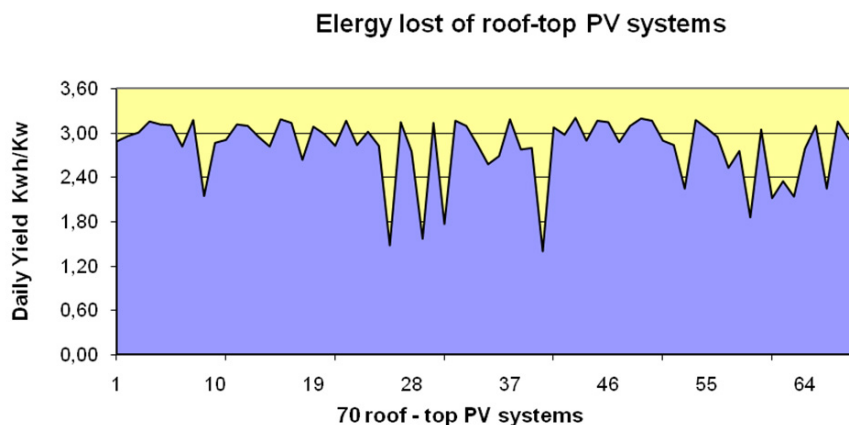
In accordance to the abovementioned, it is necessary to know how much energy is eventually lost because of these errors. In the Figure 8, we place the 70 worst energy performance roof-top PV systems in calendar binding sequence. The daily performance of 3,6 kWh/kWp, is the average performance of the systems. This diagram shows the daily energy lost in the yellow area of the graph. According to the program the anticipated energy should have been:

$$3,6 \times 70 = 252 \text{ kWh/day}$$

However, real recorded yield, as shown in the graph (blue area) is:

$$196,94 \text{ kWh/day}$$

While the remaining area of the graph (yellow area) is estimated by:

$$252 - 196,94 = 55,06 \text{ kWh/day}$$

and presents energy losses due to errors before mentioned.

Figure 8: Lost energy from the 70 worst energy performance roof-top PV systems

These losses correspond to 22% of yield that could be produced if there was more appropriate planning and construction of these systems. The remaining 78% is attributed energy yield to the grid.

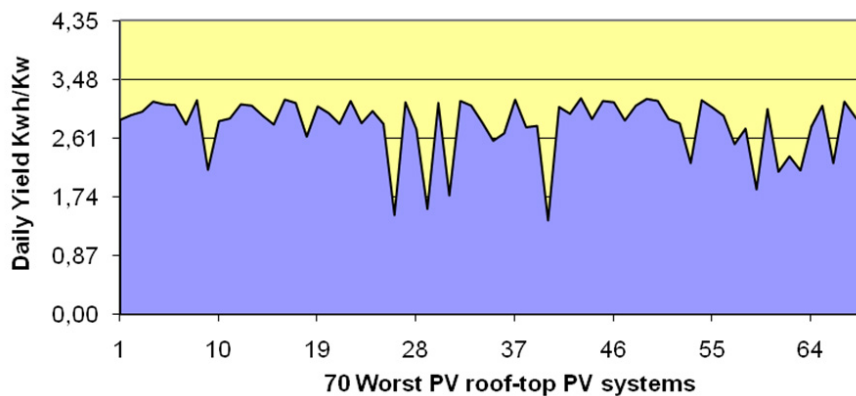
Figure 9: Lost energy from the 70 worst energy performance roof-top PV systems compared to optimal value

The situation is even worse in the case of comparison of these systems to the optimal coefficient of performance (4,35 kWh/kWp), as shown in Figure 9. That does simply illustrate the problem at the maximum dimensions.

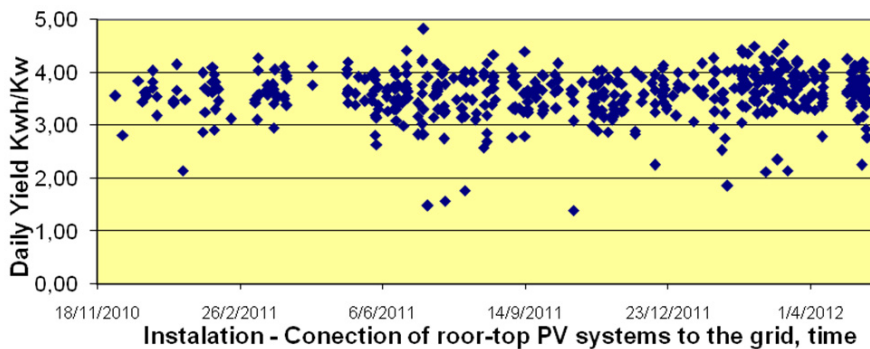
Figure 10: Characteristic curve expressing the relationship between installation time and performance of energy yield

During our investigation we observe that the first systems were connected to the grid infrequently, and as time goes, connections multiply, reaching in some cases up to five at the same day! (See Figure 10). This happen because at first, there was some hesitation from the potential investors, due to the fact that it is an innovative project, and that there was the uncertainty of the political cli-

mate of Greece in this period (economic crisis). But in time, longer hesitations in the past have vanished, and various artisans, unskilled, entered the area and managed to get a significant market share. It is therefore necessary to consider whether that fact affected system performance.

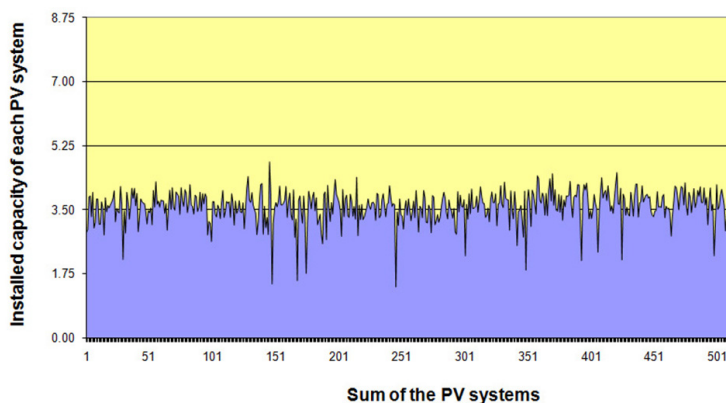
The final performance in accordance with the installed capacity is shown in the Figure 11. The vertical axis represents the installed capacity of 512 registered systems, with average 8,75kWp, while on the horizontal axis is the daily performance of the systems.

The total installed capacity is 4.49 MW, while daily production in 1.84 MWh. According to the measurements we obtained, the total daily energy yield is:

1782,19 kWh

$$1782,19/0,78=2284,85 \text{ KWh}$$

2284,85-1782,19=502,66 KWh

Figure 11: Final performance of the listed 512 systems compared to the installed capacity of roof-top PV systems
