IMPROVEMENT OF SAFETY MEASURES BY APPLYING A TECHNICAL SOLUTION ON THE M-80A INFANTRY COMBAT VEHICLE

FIELD: Mechanical engineering, Weapons

ARTICLE TYPE: Original scientific paper

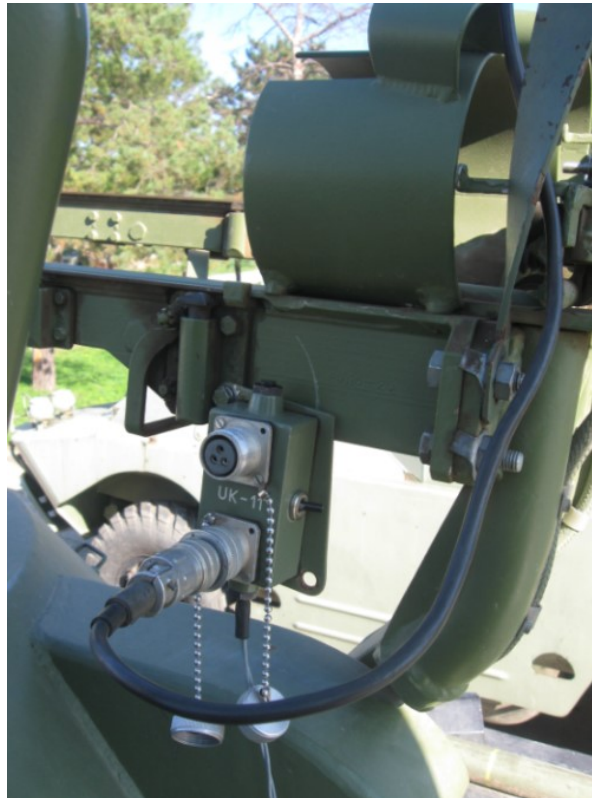
Figure 2 – Distributor
 Рис. 2 – Распределитель
 Слика 2 – Разводник

The signaling device is connected to the distributor by a three-pole contact. The distributor is installed on the anti-tank guided missile launcher and secured so that it does not obstruct the launcher operation. There are two three-pole sockets on the distributor.

The three-pole contact of the signaling device is connected to the lower socket while the three-pole contact of the additional light is connected to the upper socket.

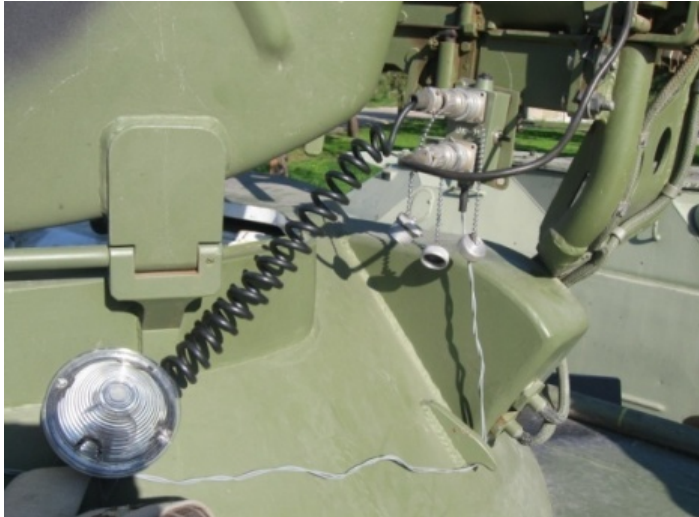
A switch intended for switching on the additional light is installed on the distributor (Figures 3a and 3b).

Figure 3a – Additional light - off
Рис. 3а – Дополнительное освещение – выкл.
Слика 3а – Додатно светло – искључено

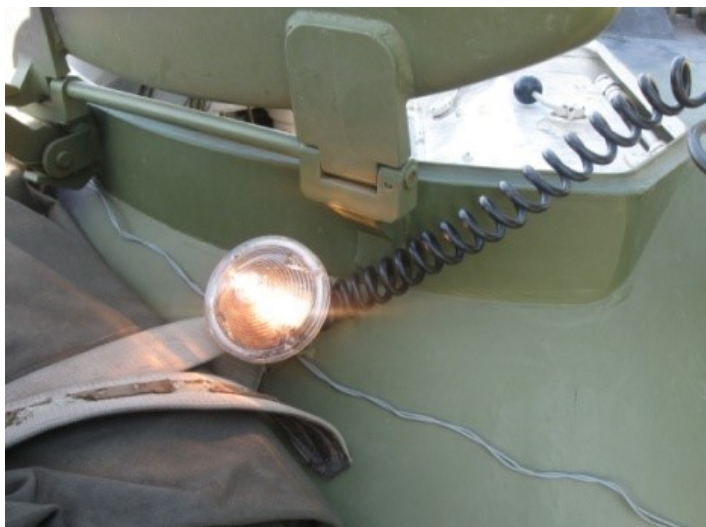
Figure 3b – Additional light – on
Рис. 3б – Дополнительное освещение – вкл.
Слика 3б – Додатно светло – укључено

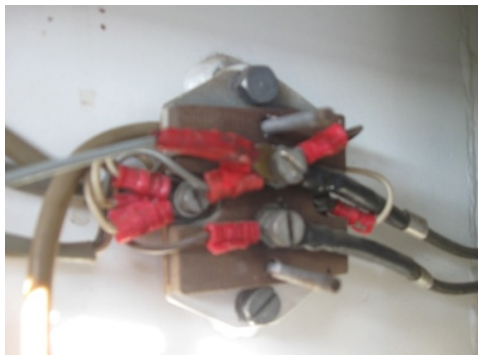
Figure 4 – "+" pole
Рис. 4 – „+“ полюс
Слика 4 – „+“ пол

The "+" pole conductor is placed and fastened to the distribution box intended for the installation of the periscope heater for a gunner – operator, Figure 4a (Savezni sekretarijat za narodnu odbranu, 1988a). The "-" pole conductor is placed on the turret edge (Figure 5).

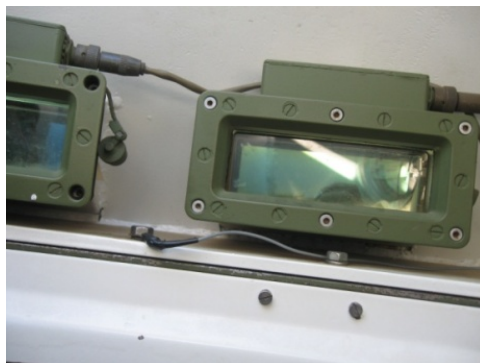
Figure 5 – "-" pole
Рис. 5 – „-“ полюс
Слика 5 – „-“ пол

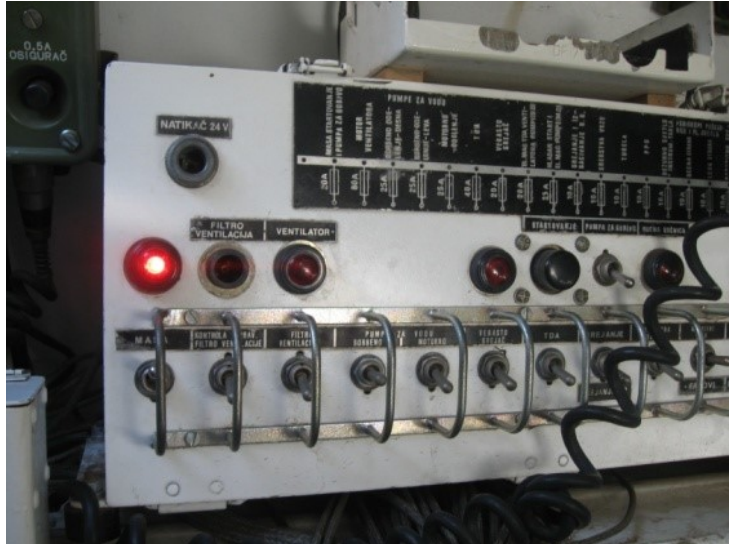
- set the "ground" switch to the upper position (Figure 6).

Figure 6 – Control panel in the BVP M-80A control section
 Рис. 6 – Панель управления в секции управления БВП М-80А
 Слика 6 – Контролна табла у управном одељењу БВП М-80А

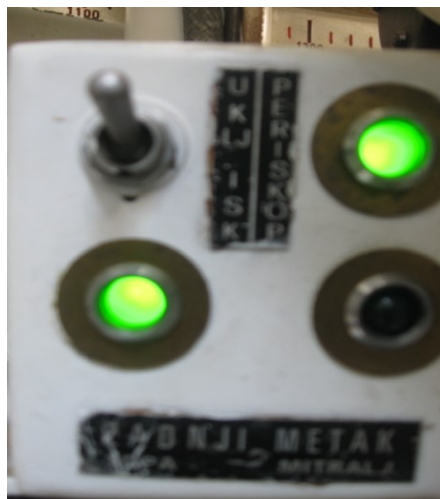
- set the gunner's periscope heater switch to the upper position (ON), Figure 7 (Končar & Isailović, 2009).

Figure 7 – Gunner's periscope heater switch
 Рис. 7 – Выключатель обогревателя перископа наводчика
 Слика 7 – Прекидач грејача перископа нишанџије

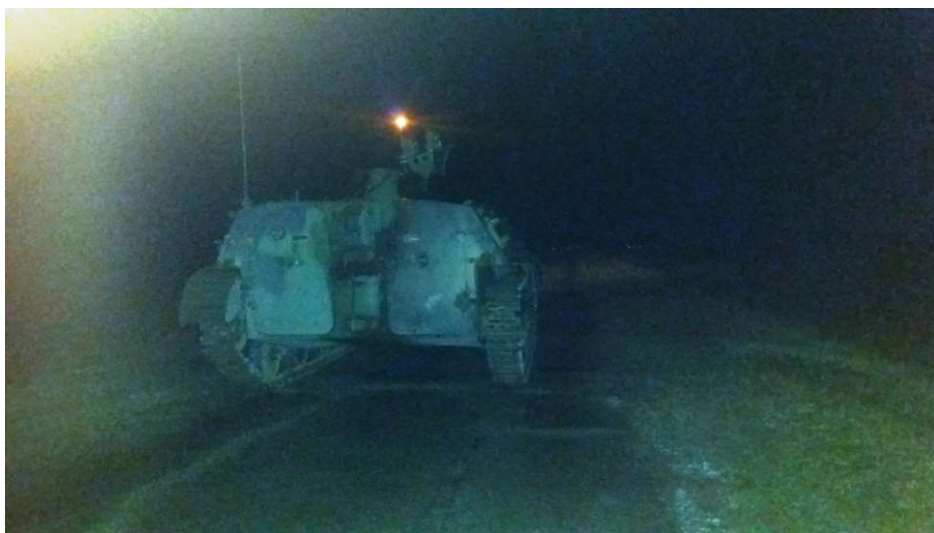
Figure 8 shows the BVP M-80A with the signalizer installed and switched on just before the start of shooting on the automated shooting range.

Figure 8 – BVP M-80A at the starting line
Рис. 8 – БВП М-80А на стартовой точке
Слика 8 – БВП М-80А на полазној линији
